Soberanes Fire
Watershed Emergency Response
Team Report

CA-BEU-003422

September 29, 2016

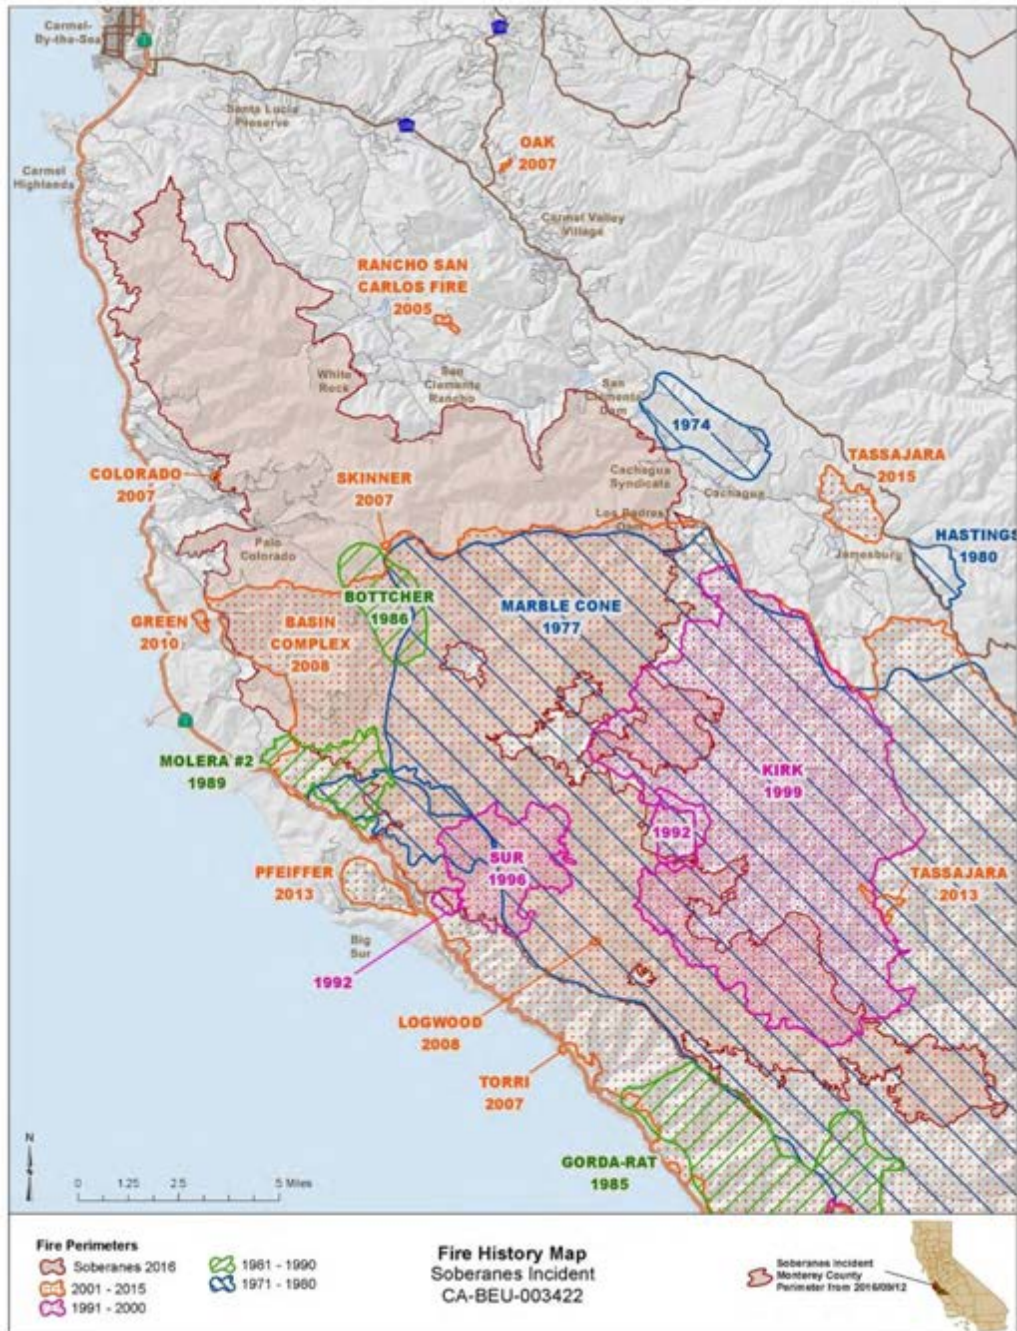
The northern third of the burn area has little to no recently recorded fire history, and this largely corresponds with the highest proportions of moderate and high soil burn severity. The southern two-thirds of the burn area have had multiple fires, and the recurrence interval of fire in this area is approximately 10-15 years (Figure 7).

Figure 7. Fire history map for the Soberanes Fire

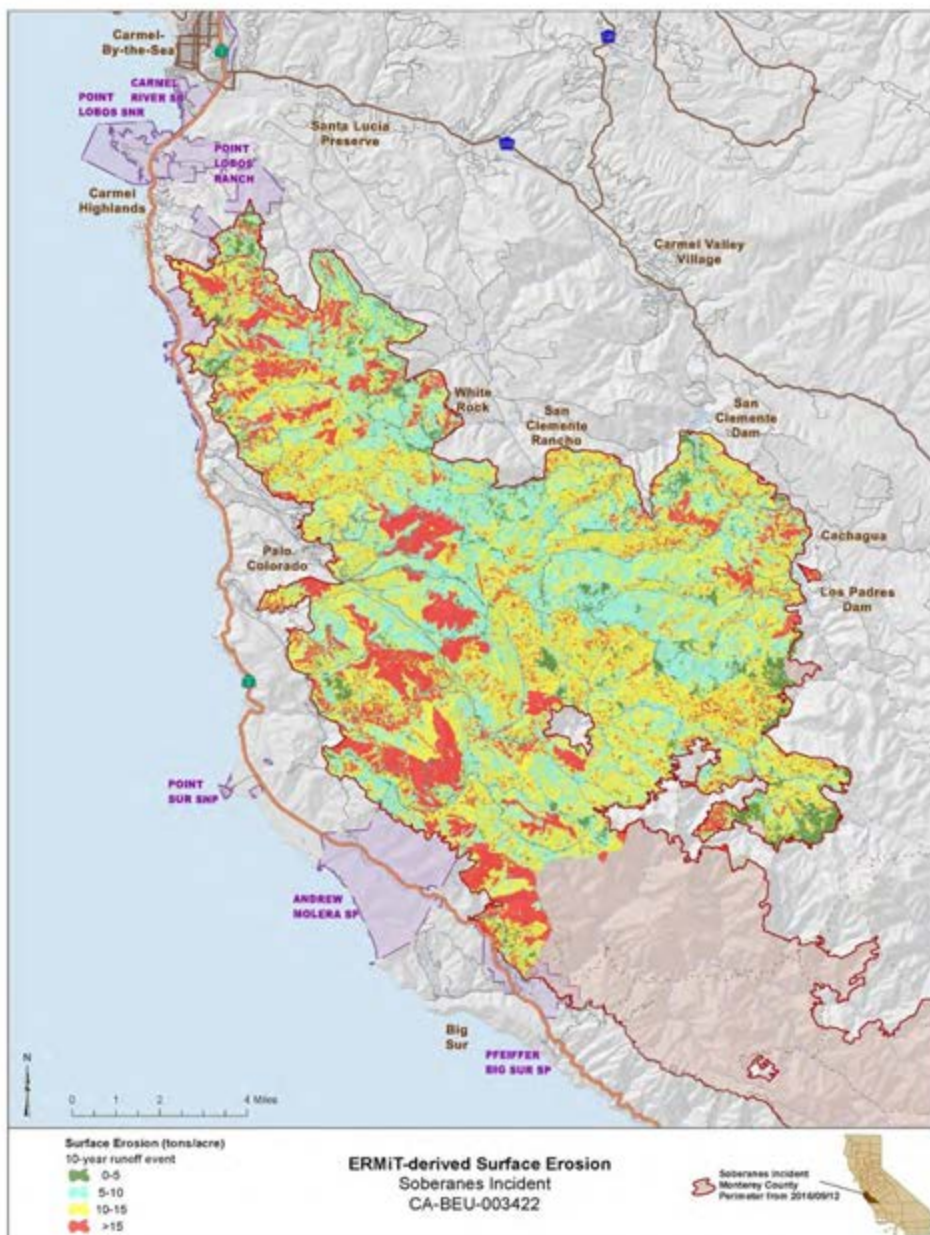
and rilling. Model predictions for the 10-year recurrence interval runoff event suggest that the highest rates of surface erosion are from steep areas burned at moderate and high soil burn severity. Rates of surface erosion for the 10-year event are estimated to be greater than 5 to 10 tons per acre (Figure 8). These rates have a 10 percent probability of exceedance. Hillslope erosion in these watersheds erosion can be expected to affect roads and drainage systems, fill watercourses with high levels of sediment, and bulk flood flows with higher than typical sediment loads.

Figure 8. Predicted surface erosion rates for the 10-year runoff event within the Soberanes burn area.

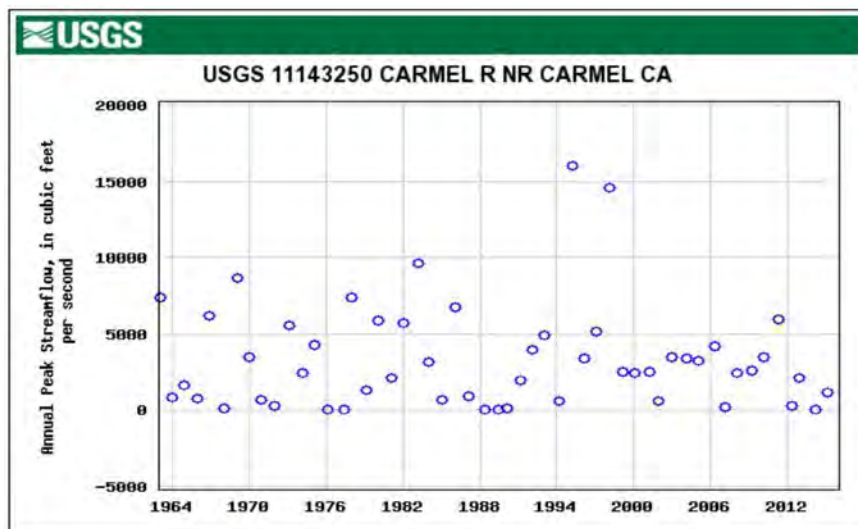
Figure 9. Annual peak flows on Carmel River near Carmel (USGS Gage No. 11143250). Peak flows for the gage were affected by upstream dams.

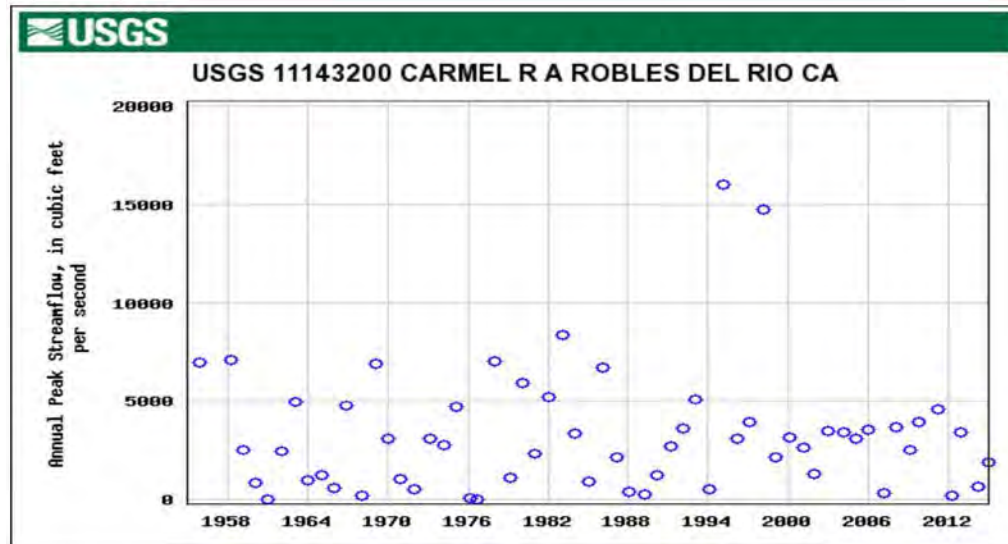
The second gage is located further upstream at Robles Del Rio in the Carmel Valley (Gage No. 11143200) and has records from 1957 to present (Figure 10). The highest peak flows recorded at both gages occurred in 1995 and 1998. The largest was in 1995 when a peak flow of 16,000 cfs was recorded at the Carmel gage (No. 11143250) and is roughly equivalent to a 30-year flood event.

Figure 10. Annual peak flows on Carmel River at Robles Del Rio (USGS Gage No. 11143200). Peak flows for the gage were affected by upstream dams.

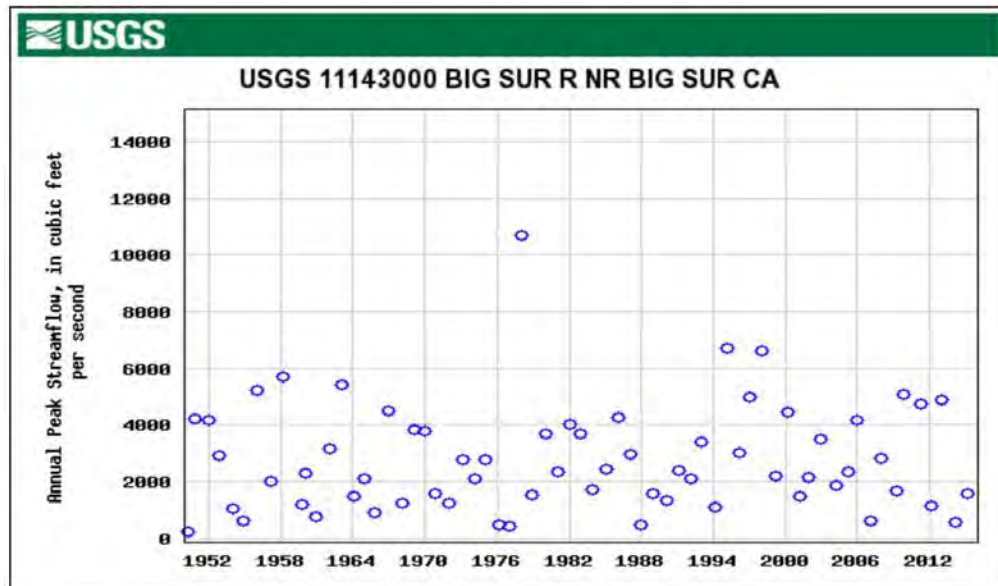
Figure 11. Annual peak flows on Big Sur River near Big Sur (USGS Gage No. 11143000).
