California Department of Forestry and Fire Protection

Review Report of Serious CAL FIRE Injuries, Illnesses, Accidents and Near-Miss Incidents

**Burn-Over and Shelter Deployment
Nine Injuries
One Engine Destroyed
One Engine with Major Damage**

**Inyo Complex
Seven Oak Fire**

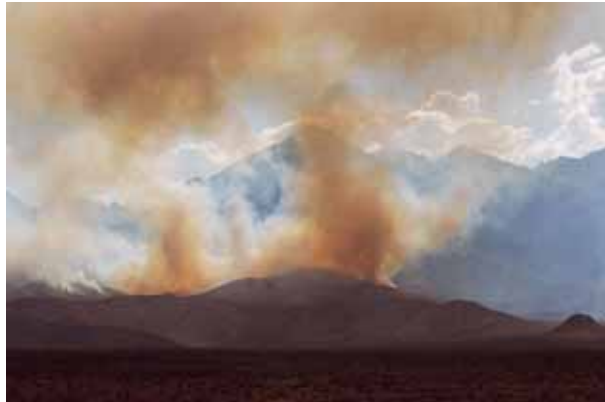
The Oak Fire, Friday afternoon, east of the Mt. Whitney Fish Hatchery

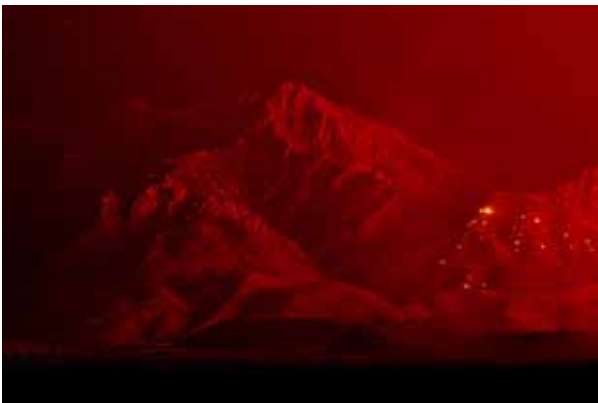
The Oak Fire, Friday night, east of the fish hatchery

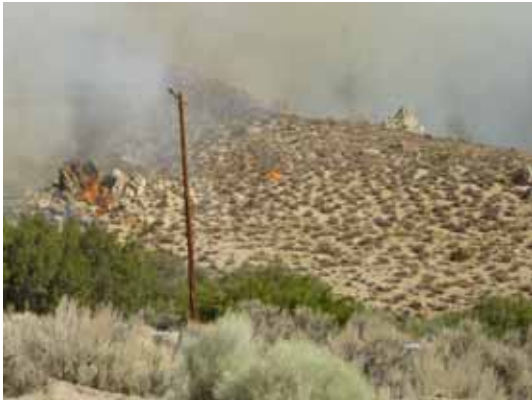
Fire above the Bright Ranch approximately 0820 hours.

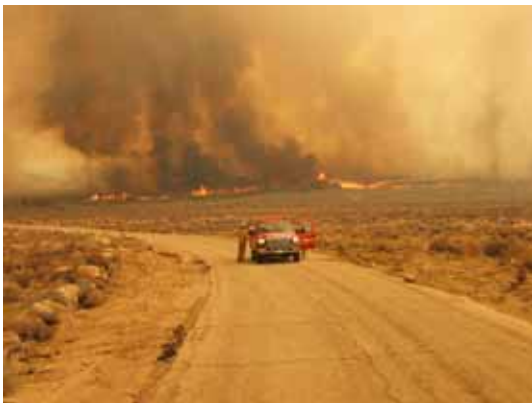
Fire coming down toward the hatchery.

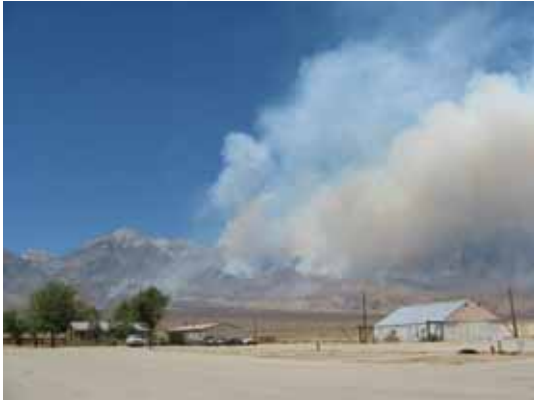
View of the Seven Oak Fire from the airport, 1150 hours

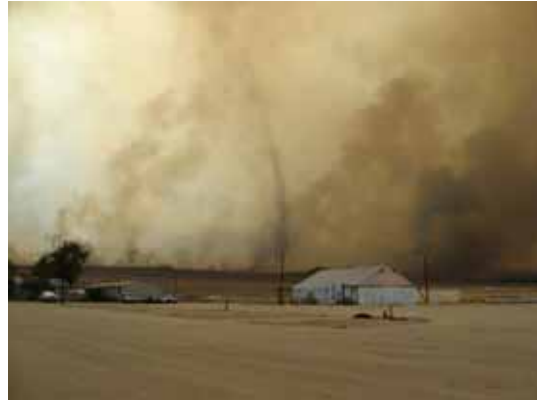
View of the Seven Oak Fire from the airport, 1428 hours

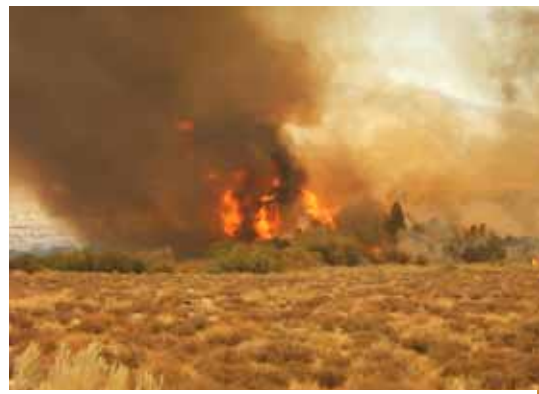
Firefighter photo during entrapment.

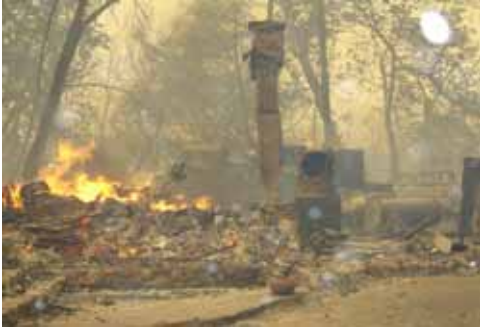
Group re-enters burn-over site and takes pictures.

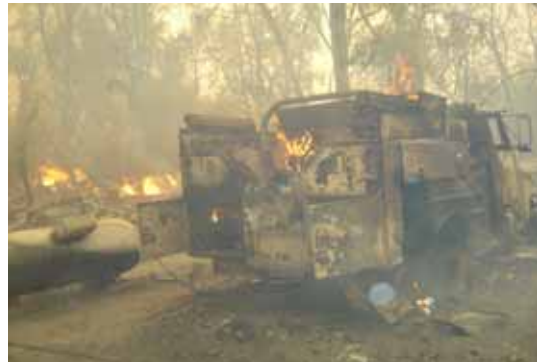
The house adjacent to Engine 4452 continued to burn, eventually spreading to and igniting the engine. At approximately 1545 hours, the two engine crews were able to walk out of the accident site and join the rest of their strike team out on the road.

Engine 4452 burning.
