Jesusita-Spyglass Accident Web Gear Analysis

May 29, 2009

Tom Foley, Deputy Chief Operations, CAL FIRE
Kevin Gains, Battalion Chief, CAL FIRE

Re: Web Gear / Line Pack Heat Exposure Analysis

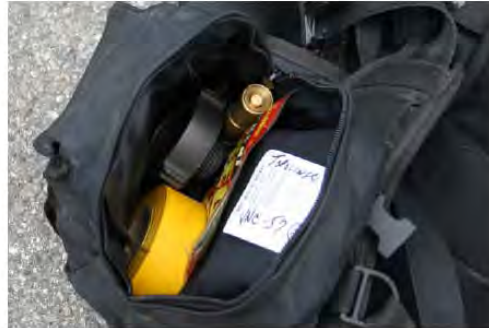
The contents of the bag are undamaged.

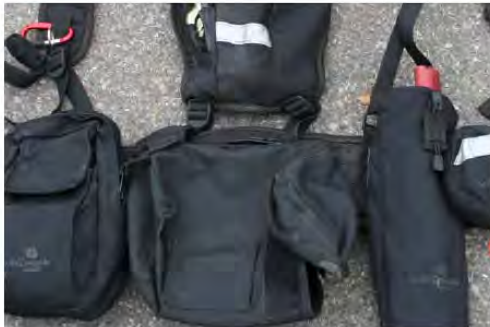
Fire Shelter Case from a Detachable Day pack
SKU: DDP-HR-2400-BK
Lot #: Undetermined

The shelter case is intact with the cover flap partially open. Minor damage is noted to the loop material at the opening.

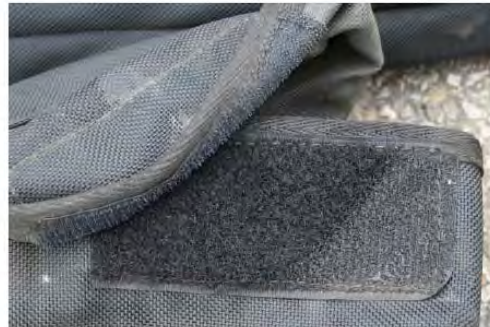
A clear line is visible indicating the position of the cover flap at the time of exposure. The damage to the loop material that was exposed is consistent with exposure to temperatures of 450 degrees and above for short periods of time. The bag did not ignite or drip.

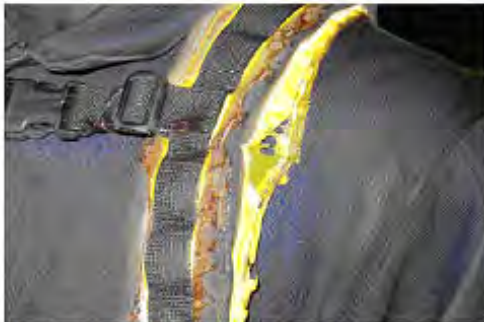
Mannequin test results at the University of Alberta.

Note that the fabric has melted onto the protective garment and the damage to the underlying foam panel.

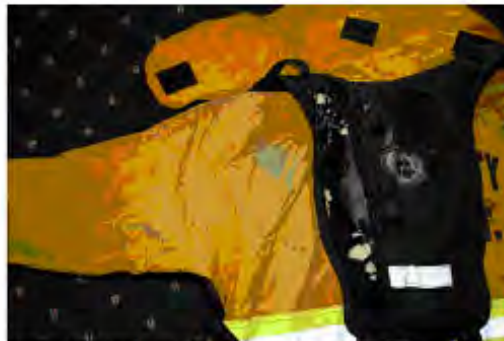
Nomex Jacket and pack system worn by [REDACTED]

The damage sustained to the fabric on the left side of the hydration pocket is unique and inconsistent in a couple of ways. First, the damage appears to be very severe to the 1050 Denier Ballistic Nylon which has a higher mass and melting temperature than the foam panel behind it. Similarly, the seam binding in close proximity does not appear to be affected to the degree that the fabric is. Secondly, similar assemblies have failed during testing and the result is usually a transfer of melted plastic to the protective clothing and any equipment that may have come into contact with it.

Conversely, [REDACTED] PPE shows no sign of material transfer on either his Nomex jacket or the SCBA.

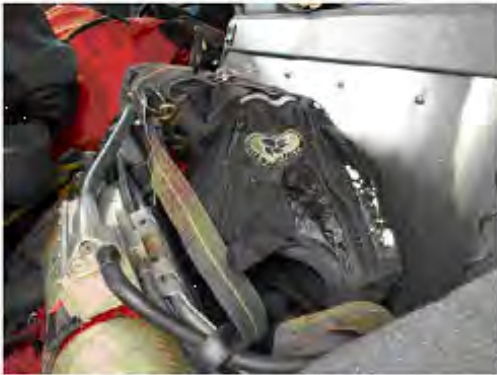
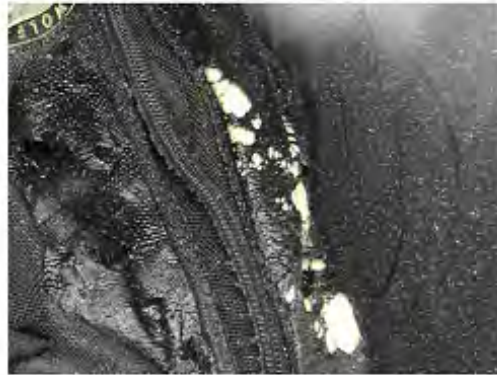
During the inspection of photographs taken at the accident site [REDACTED] pack system is seen in the right rear passenger compartment of E54 with the SCBA worn during the event. These items were discarded by [REDACTED] after seeking refuge in E54. The pack system is situated between the SCBA and the rear of the engine cover. Upon closer inspection the pack system at the point of damage to the hydration pocket is in contact with the engine cover and a melting to the cover.

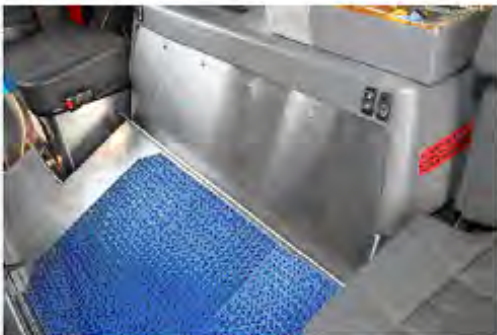
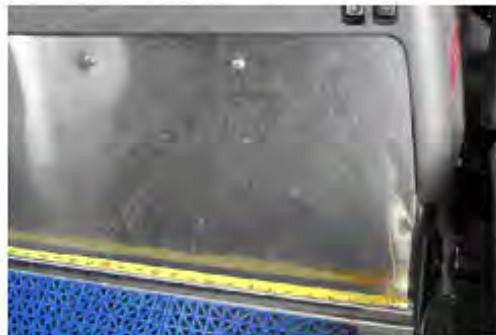
An inspection of the engine cover revealed that small pieces of the melted fabric remained on the engine cover after the removal of the pack system.

This is consistent with the earlier observation that creases, wrinkling and matting of the fabric indicate that the material was in contact with a relatively flat surface while at or very close to its melting temperature. The lack of melted material transfer to either the Nomex jacket or SCBA indicates that the melting most likely did not occur until the pack was removed and discarded in E54.
