MEMORANDUM

DATE: May 12, 2016

SUBJECT: Soquel Creek Large Woody Debris Habitat Complexity and Streambank/Road Repair Projects, 2015 Annual Physical Monitoring Report

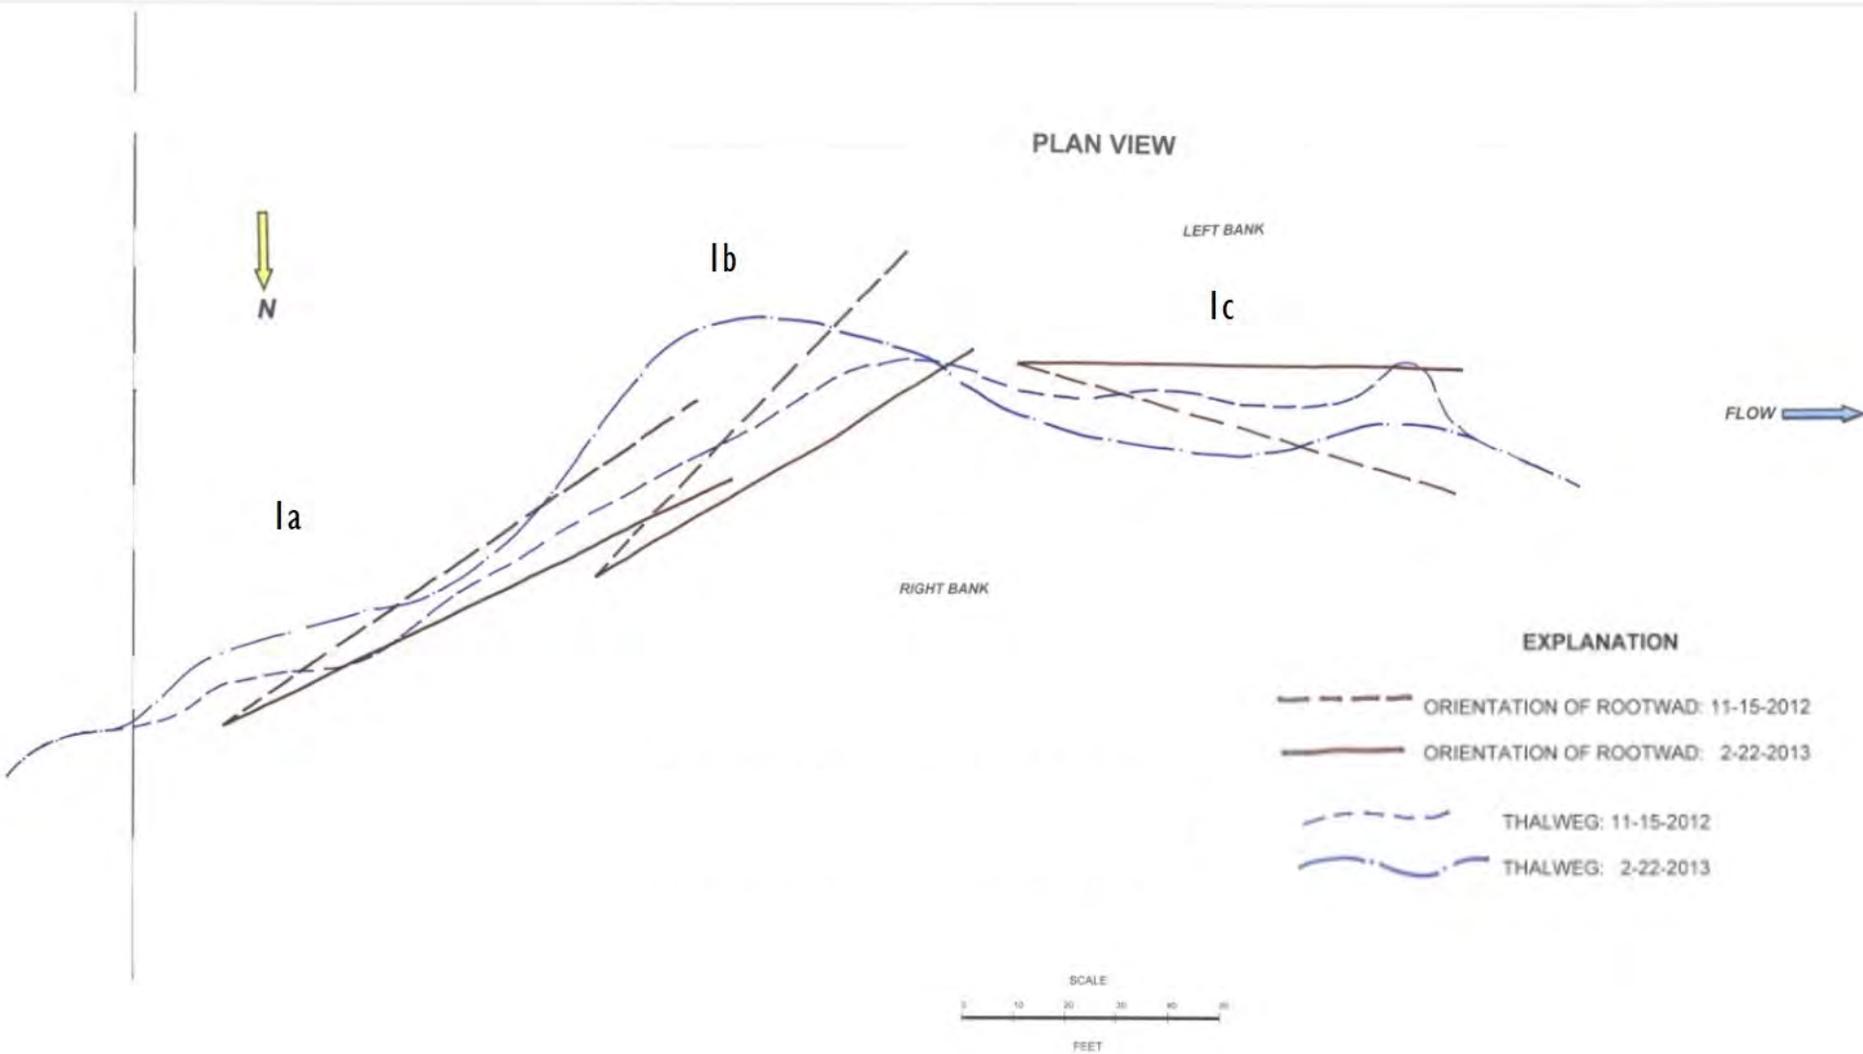
Figure 2: Site 1 Rootwad Monitoring

the creek to an orientation more in line with the flow direction. Figure 2 shows the change in stem orientation at each of the Site 1 structures.

The storm flows also had an effect on the orientation of the large wood elements. Each of the three rootwad structures with stems were rotated during the higher flows, aligning more with the

downstream flow path than at the angle originally installed. While the stems rotated, the overall large elements remained in place, performing as designed to remain meta-stable during 5-year return interval events. Several smaller logs incorporated into the large wood elements shifted and one 31-inch diameter, 42-foot long redwood log dislodged from where originally pinned at Site 1b and was found approximately 1,100 feet downstream lodged against a large boulder near Site 2c. The rotation of the large wood elements is shown in Figure 2.

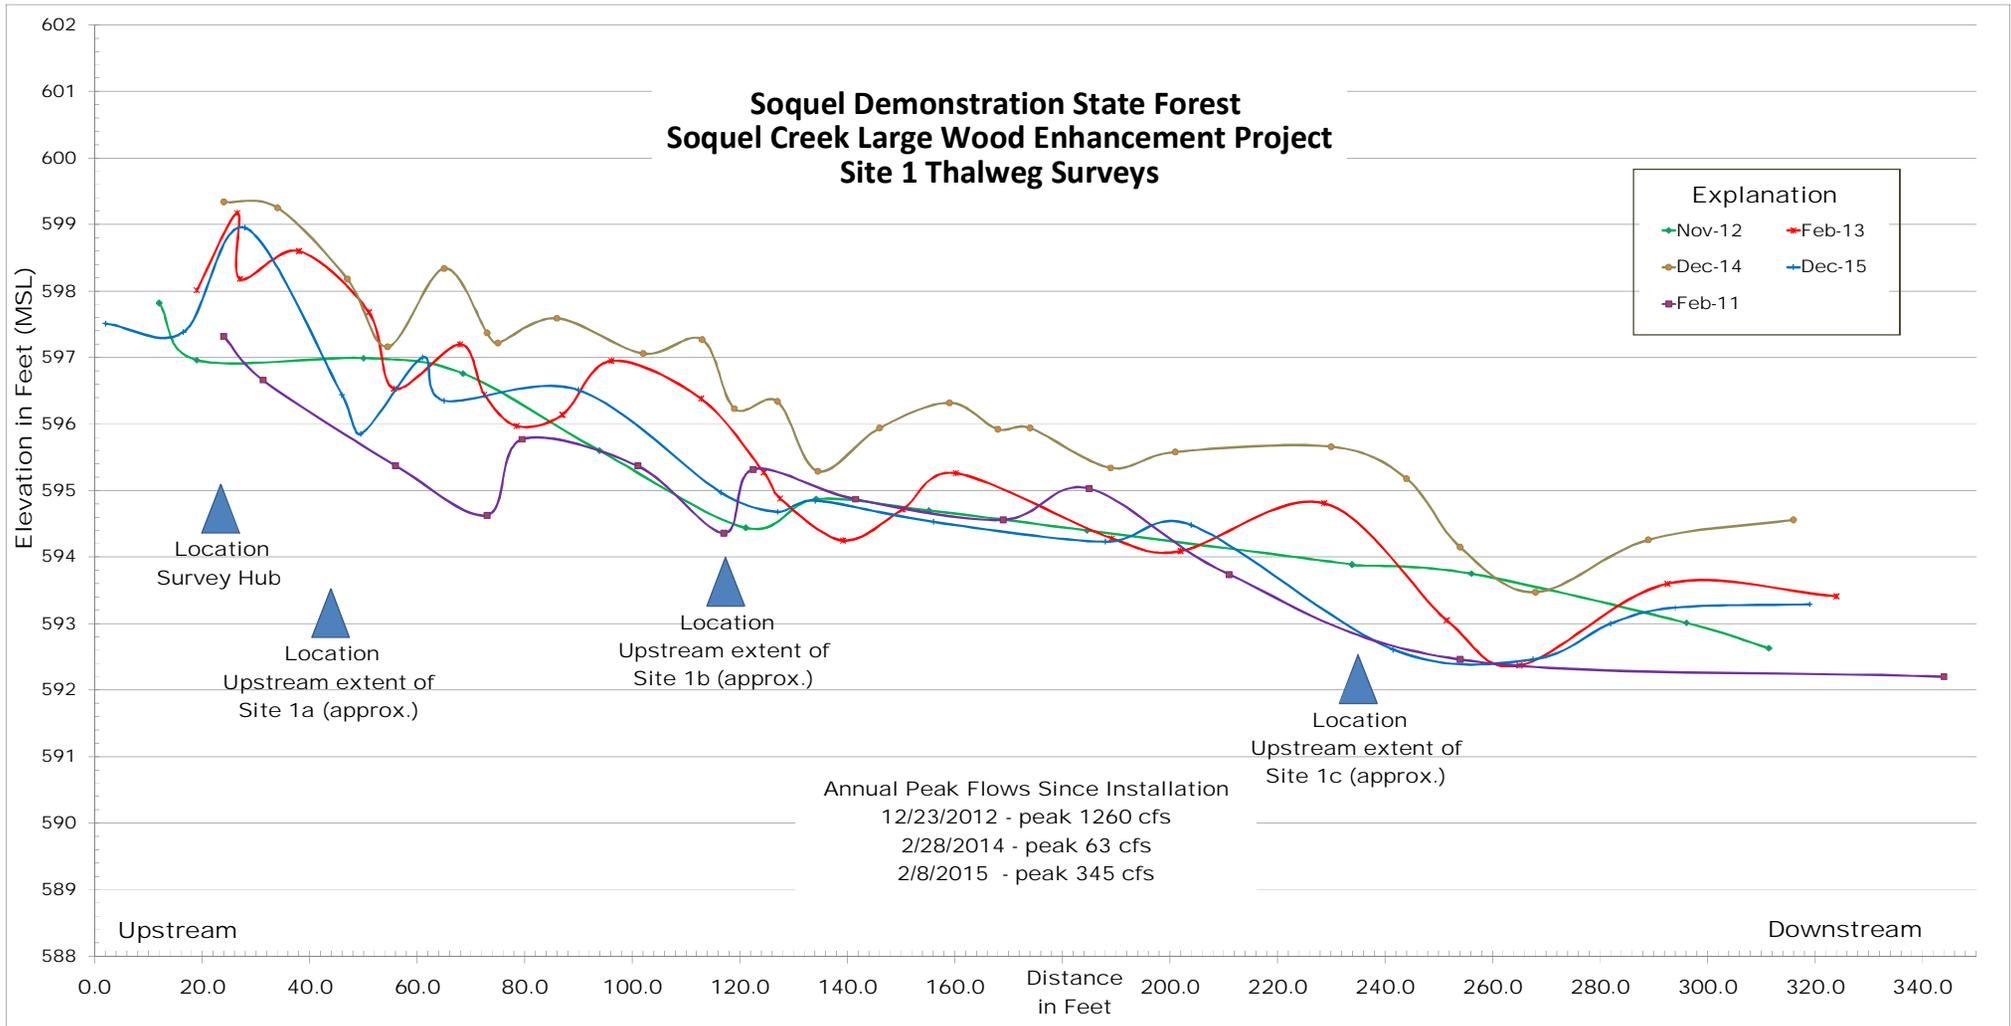
Figure 3: Site 1 Thalweg Profile

November 2012 Survey. Site 1 LWD was installed in September 2012. The Site 1 post-installation survey profile reflects a uniform channel with one incipient pool. An incipient pool, for the purpose of the large wood monitoring, is defined as a bed roughness element less than 1-foot in residual depth, meaning the depth calculated from the low point of the roughness element to the top of the next downstream riffle crest or high point, irrespective of water depth. A pool is defined as a bed roughness element having a residual depth of 1-foot and greater.

February 2013 Survey. This survey was conducted after placement of LWD at Site 1 and prior to placement of LWD at sites 2, 4, and 5. This survey reflects significant changes to channel morphology relative to the previous survey (CGS, 2013) after the occurrence of an approximately 4-year return interval storm and an approximately 8-year return interval storm that occurred in December 2012. The most significant change was an increase from 0 to 2 pools (1.01 and 1.23 feet deep) and 1 incipient pool to 4 incipient pools with depths ranging from approximately 0.42 to 0.98 feet. In addition to the increase in pools and bed roughness, it appears that approximately ½ to 1 ½ feet of channel aggradation occurred primarily at the area immediately upstream of the upstream end of each large wood element.

December 2014 Survey. The December 2014 survey indicates two pools (1.18 and 1.03 feet deep) remain, although their locations within the reach have shifted. There also appears to be the development of an additional incipient pool, increasing the number of incipient pools to 5, with depths of approximately 0.11 to 0.79 feet. Nearly the entire reach has locally aggraded with channel elevations increased approximately 1 ½ feet from the previous survey (February 2013) and nearly 3 feet when compared to the February 2011 pre-installation survey.

December 2015 Survey. The December 2015 survey indicates the presence of one pool (1.15 feet deep) and four incipient pools (0.16 to 0.78 feet deep). The thalweg profile appears to have smoothed out compared to the previous survey (CGS, 2015) with fewer pools and incipient pools. While there may have been a reduction in the number of pools and incipient pools, the larger pool and incipient pool appear to be increasing in size. The pools and incipient pools in near proximity to the large wood structures appear to be relatively stable features with minor fluctuations in depth and position. Additionally, the thalweg profile has degraded approximately ½ foot to 2 1/2 feet within the reach since the previous survey (CGS, 2015), and appears to be returning to pre- and immediately post-installation levels. These channel changes are represented in Figure 3.

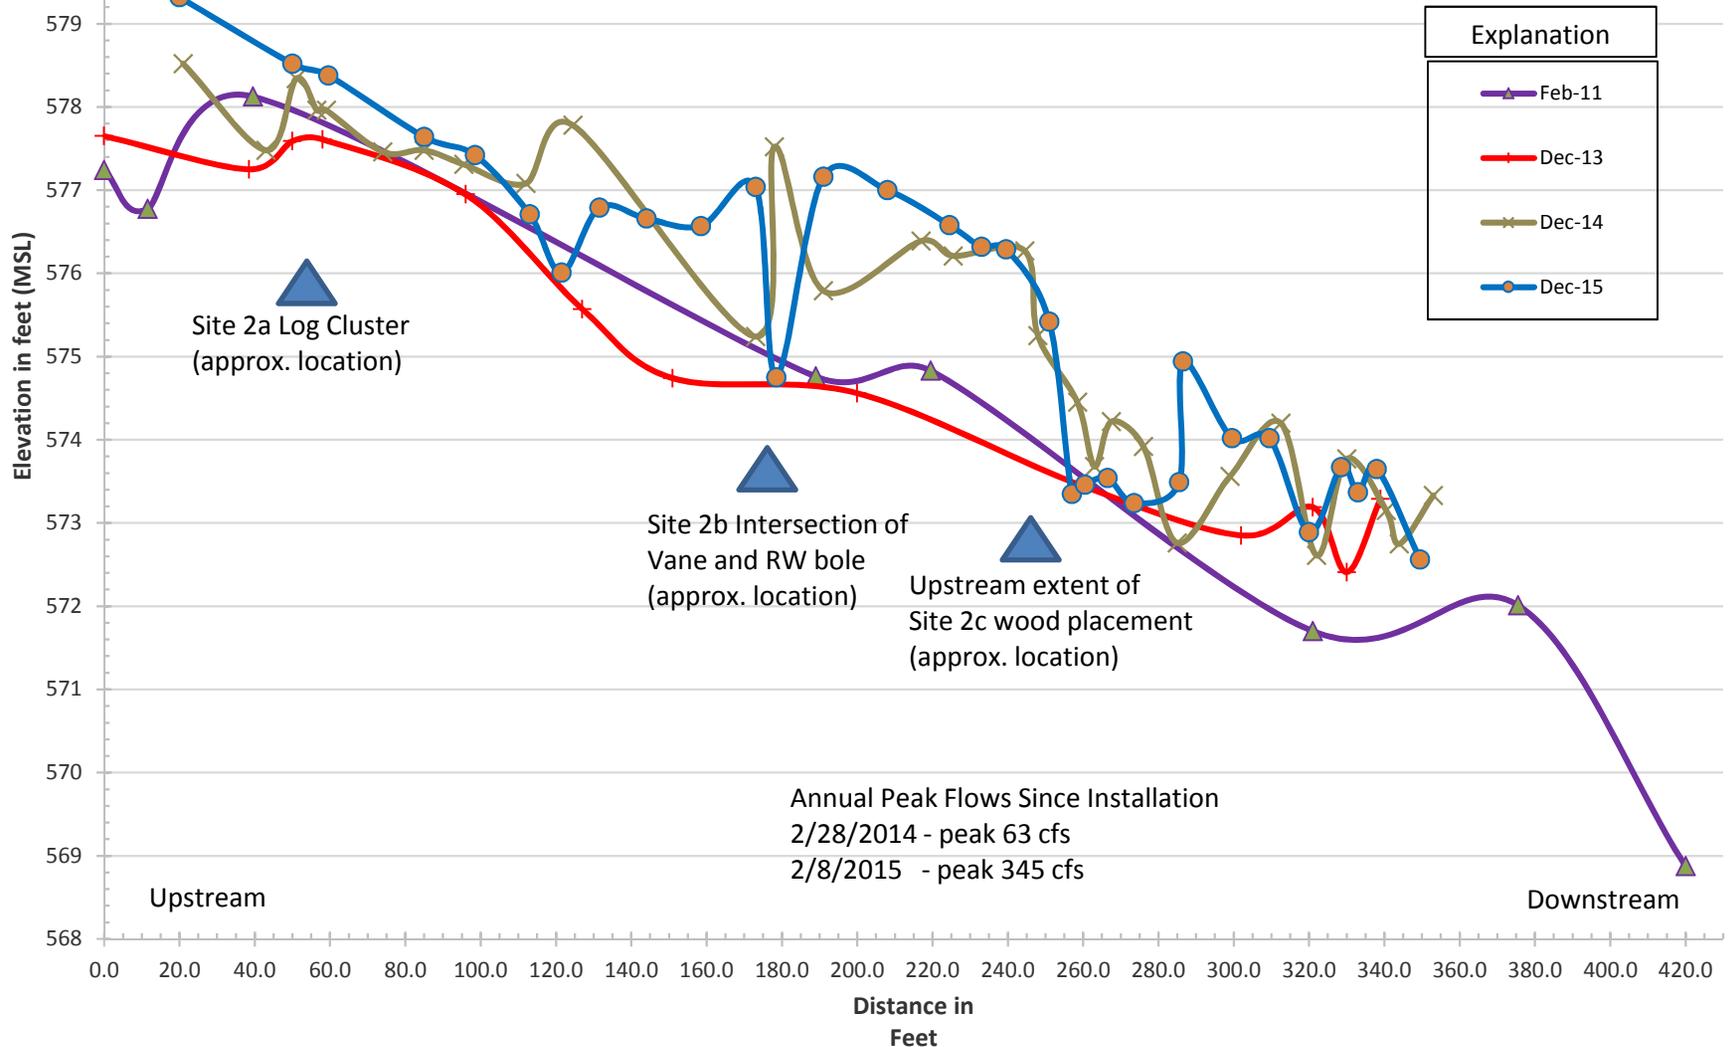
Figure 4: Site 2 Thalweg Profile

October 2013 and December 2014 Surveys. Site 2 LWD installation occurred in August 2013. Comparison of the October 2013 and December 2014 surveys indicate the thalweg profile at Site 2 has changed relatively dramatically following installation of the large wood elements even though the largest storm was only a 1.4-year return interval. The number of pools increased from 3 incipient pools (0.36 to 0.61 feet deep) present at the time of installation to 3 pools (1.16 to 2.28 feet deep) and 5 incipient pools (0.54 to 0.86 feet deep) post installation. Immediately upstream of the Site 2c rootwad backstop structure, channel elevation locally increased approximately 2 ½ feet with aggraded stream gravels. The aggraded material appears to extend upstream from the rootwad backstop a distance of approximately 200 feet. At Site 2b a 2.3-foot deep scour pool was measured at the location of the rootwad cover for the vane log. Scour pools appear to have increased in depth, ranging from less than 1-foot in depth before installation to approximately 0.5 to 2.3 feet deep after installation. For example, at Site 2a (location of the log cluster structure) a scour pool has deepened by approximately 0.5 feet when compared to the previous survey.

December 2015 Survey. The December 2015 thalweg survey indicates the presence of three pools (1.03 to 2.41 feet deep) and three incipient pools (0.28 to 0.78 feet deep). The number of pools remained from the previous survey and there was a slight decrease in incipient pools from five to three when compared to the 2014 survey. The pools associated with large wood structures 2b and 2c appear to be generally stable in terms of their location. The thalweg profile appears to remain dynamic through this reach with locations of both relative aggradation and degradation with respect

to the December 2013 survey. Overall, the channel remains aggraded throughout the center of the reach in comparison to pre- and immediately post-installation surveys. Both the log vane structure (2b) and the rootwad backstop structure (2c) appear to be effectively retaining gravels resulting in localized aggradation. Though not reflected in the thalweg survey, a large gravel bar was observed to have built up along the right bank upstream of Site 2b and one of the logs from the Site 2a log cluster mobilized and moved downstream where it was entrained in the Site 2c rootwad backstop structure. The remaining three logs at Site 2a have been rotated and repositioned within that site location. This reach seems to have the most fluctuation with regard to both thalweg adjustments and site adjustments in comparison to the other three large wood sites (1, 4, and 5) even though the flow events have remained relatively low with a maximum of a 1.7 year return interval since installation. These channel changes are represented in Figure 4.

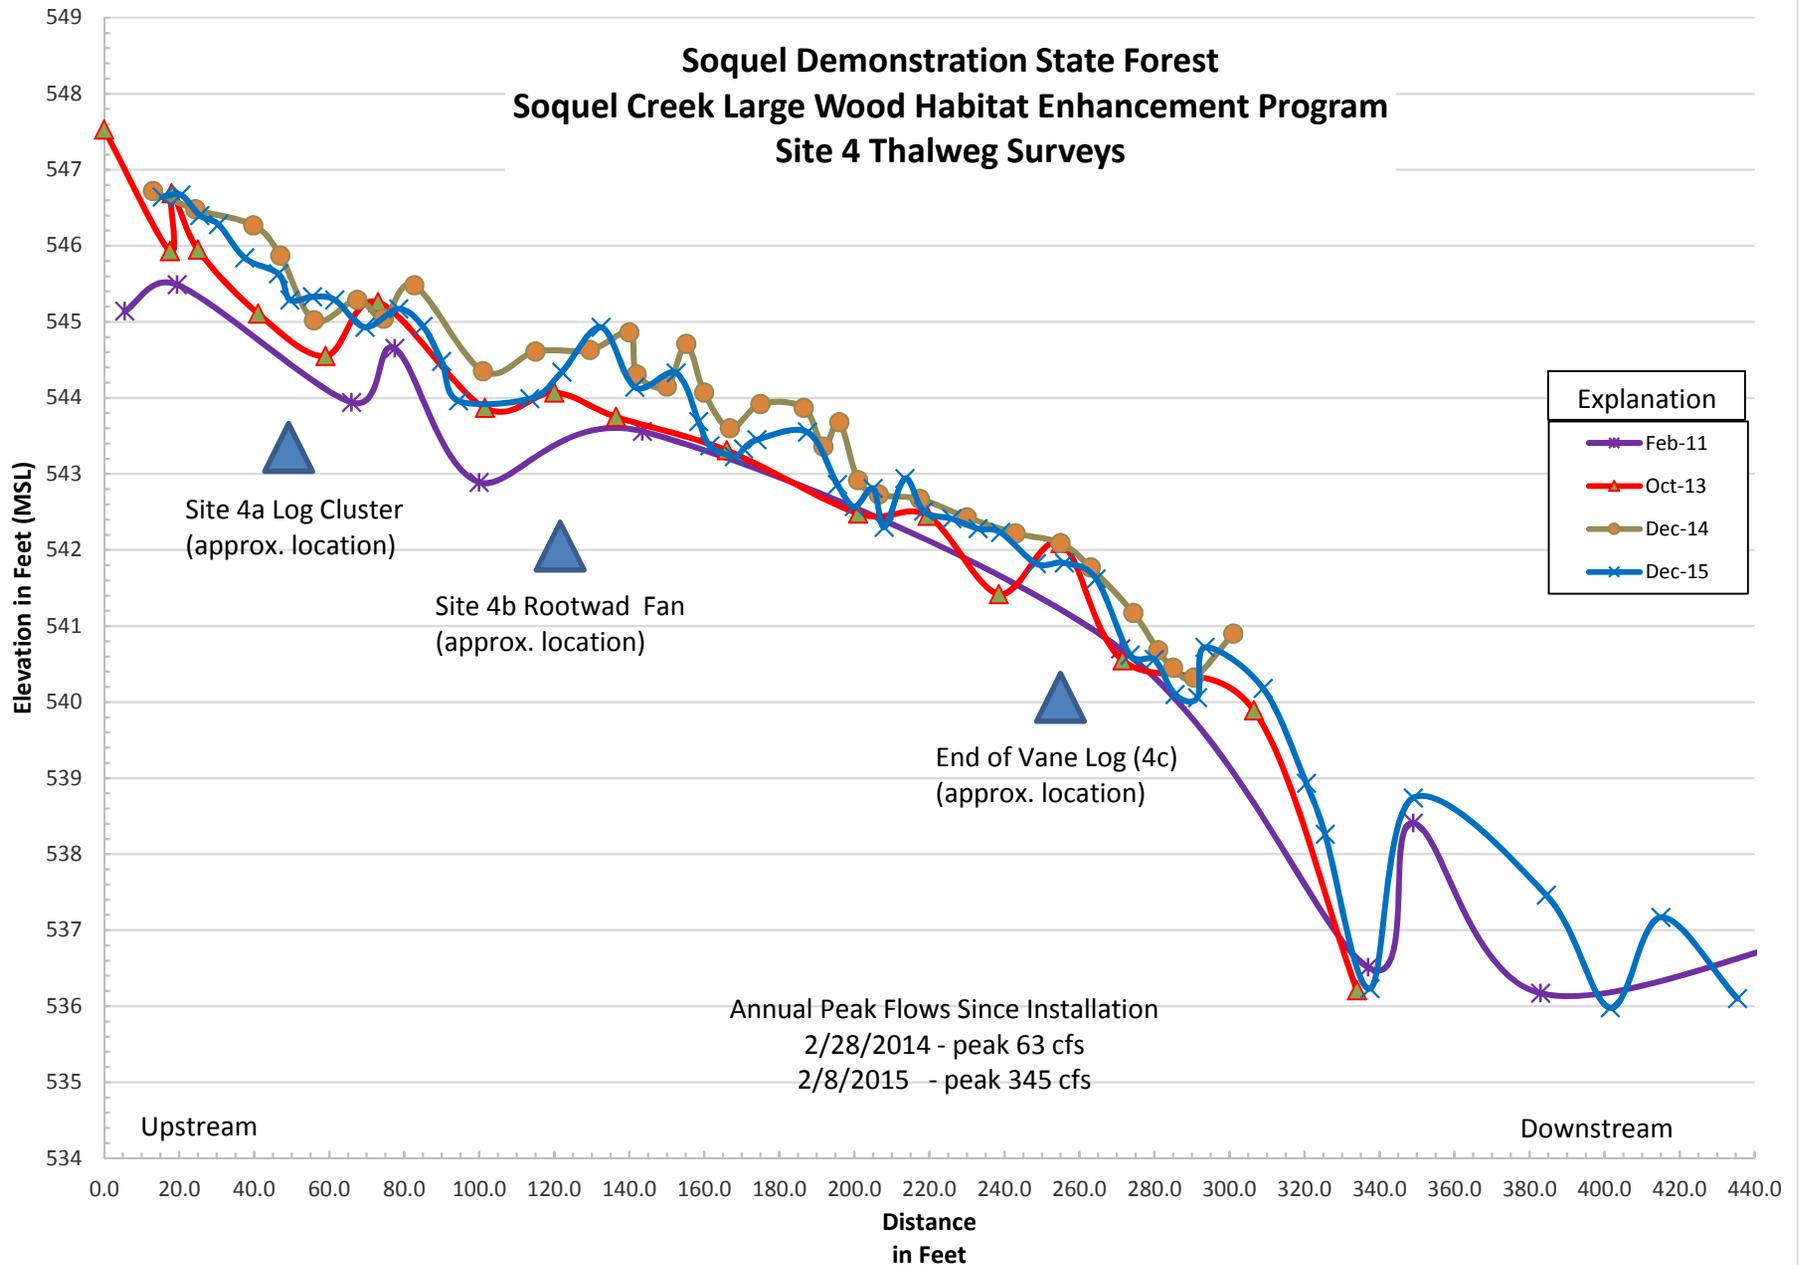
Figure 5: Site 4 Thalweg Profile

October 2013 and December 2014 Surveys. Site 4 LWD installation was conducted in September 2013. Site 4 exhibited relatively modest changes in post channel morphology following installation when comparing the October 2013 and December 2014 surveys, recognizing that the largest storm over this period had a 1.4-year return interval. The number of incipient pools increased from four (0.20 to 0.76 feet deep) to six (0.32 to 0.58 feet deep). Channel elevation appears to have locally increased (via aggradation) approximately ½ to 1 foot through most of the reach distance.

December 2015 Survey. The December 2015 survey appears relatively consistent with the 2014 survey. There are still six incipient pools (0.19 to 0.97 feet deep), although the deepest one has increased in depth and is nearly a pool. The survey through this reach extended farther than it did the previous year and captured one pool downstream of Site 4c (2.51 feet deep) that was also present in 2011 and partially captured in the 2013 survey. This larger pool appears to be relatively stable with regard to depth and location. There does not appear to be any significant aggradation or degradation through the reach when compared to 2014. These channel changes are represented in Figure 5.

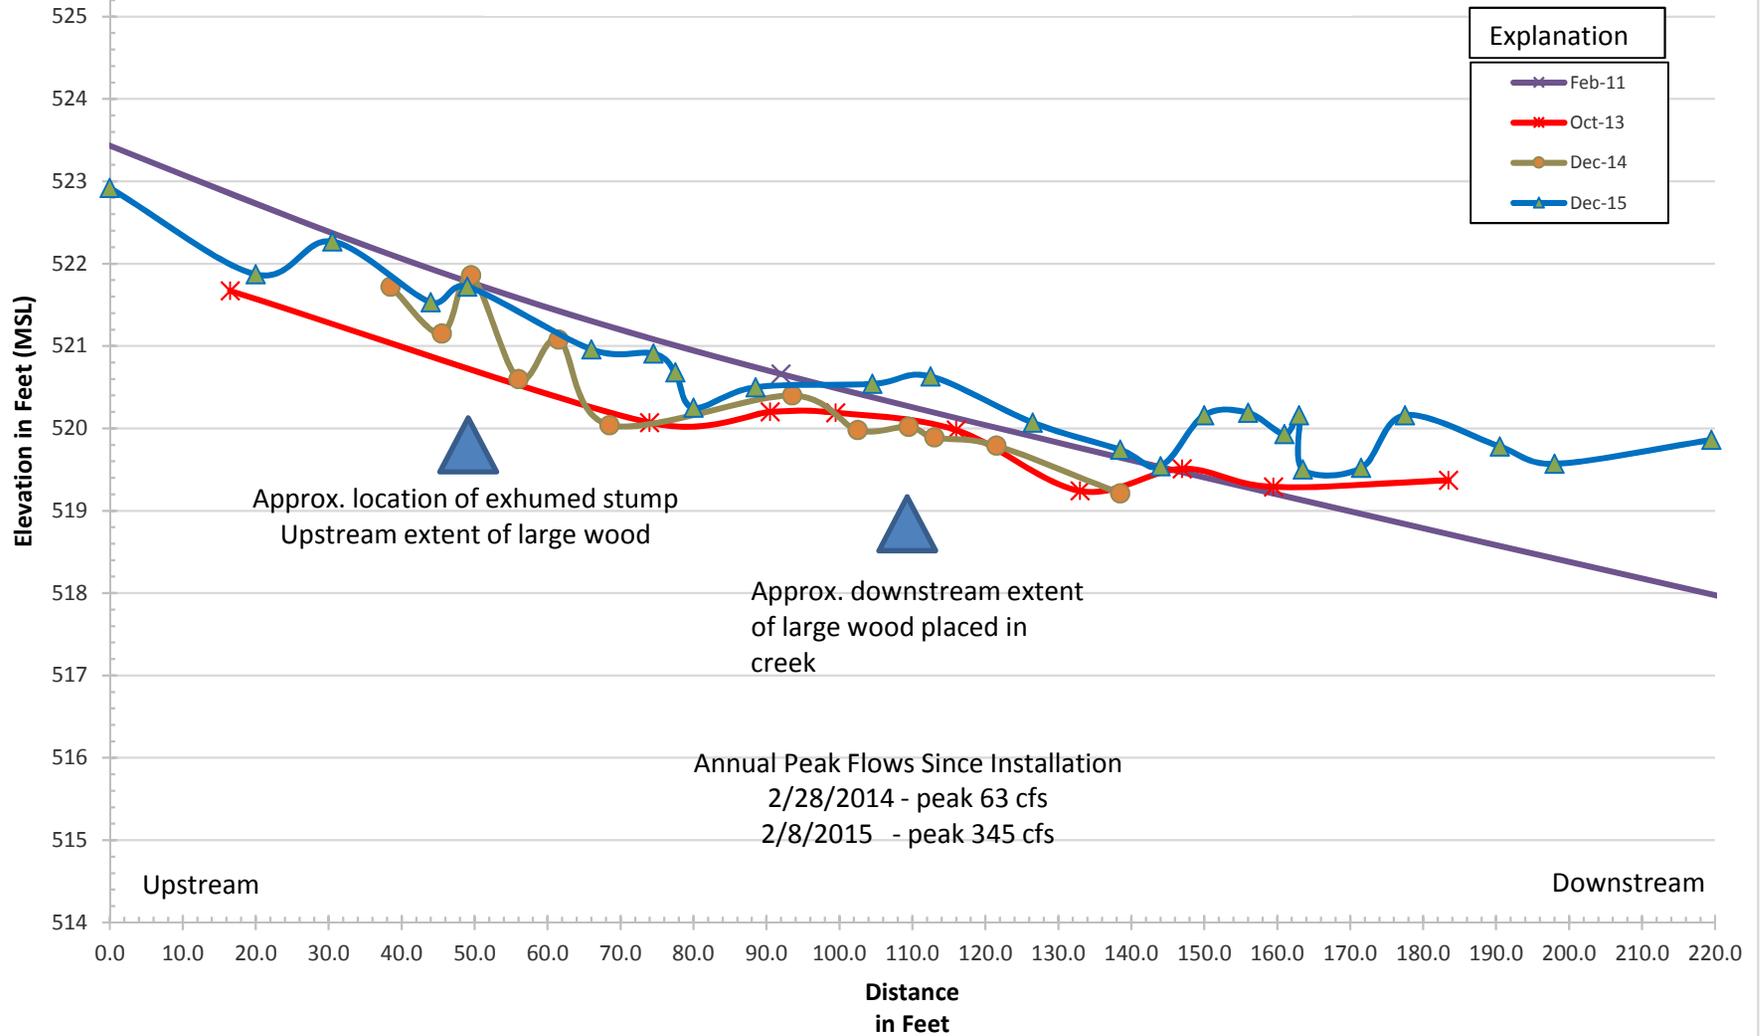
Figure 6: Site 5 Thalweg Profile

October 2013 and December 2014 Surveys. Site 5 LWD installation was conducted in September 2013. A comparison of the Site 5 surveys indicates only slight changes in channel morphology since LWD installation, recognizing that the largest storm over this period had a 1.4-year return interval. At the time of installation, the channel was fairly uniform with only two incipient pools (0.13 and 0.27 feet deep). The December 2014 survey indicates an increase to three incipient pools (ranging from 0.36 to 0.71 feet deep) and channel elevation appears to have locally increased (via aggradation) approximately ½ to 1 foot over a distance of more than 25 feet upstream of the log cluster. An exhumed stump is represented in Figure 6 that was used as an elevation control point between the two surveys. Several stumps appear in and adjacent to the channel at Site 5 and appear to have been previously buried by valley infill of sediment and then subsequently exhumed by modern Soquel Creek channel lowering.

December 2015 Survey. Within the survey distance of the 2014 survey, it appears that the thalweg profile has smoothed a bit and that there was a decrease in the number of incipient pools from three

to two. However, the 2015 survey extended beyond the 2014 survey in both the upstream and downstream directions and covered a similar distance as the 2013 survey. Within the distance encompassing both the 2013 and 2014 surveys, the 2015 survey indicates the presence of six incipient pools ranging from 0.19 to 0.66 feet deep. No significant aggradation or scour appears to have occurred since 2014. The local aggradation since 2013 in the vicinity of the wood structure appears to remain in place. Additionally, as can be seen in the Appendix D Photos, a log in the structure has rotated from parallel to the bank to spanning the channel. The channel changes are represented in Figure 6.

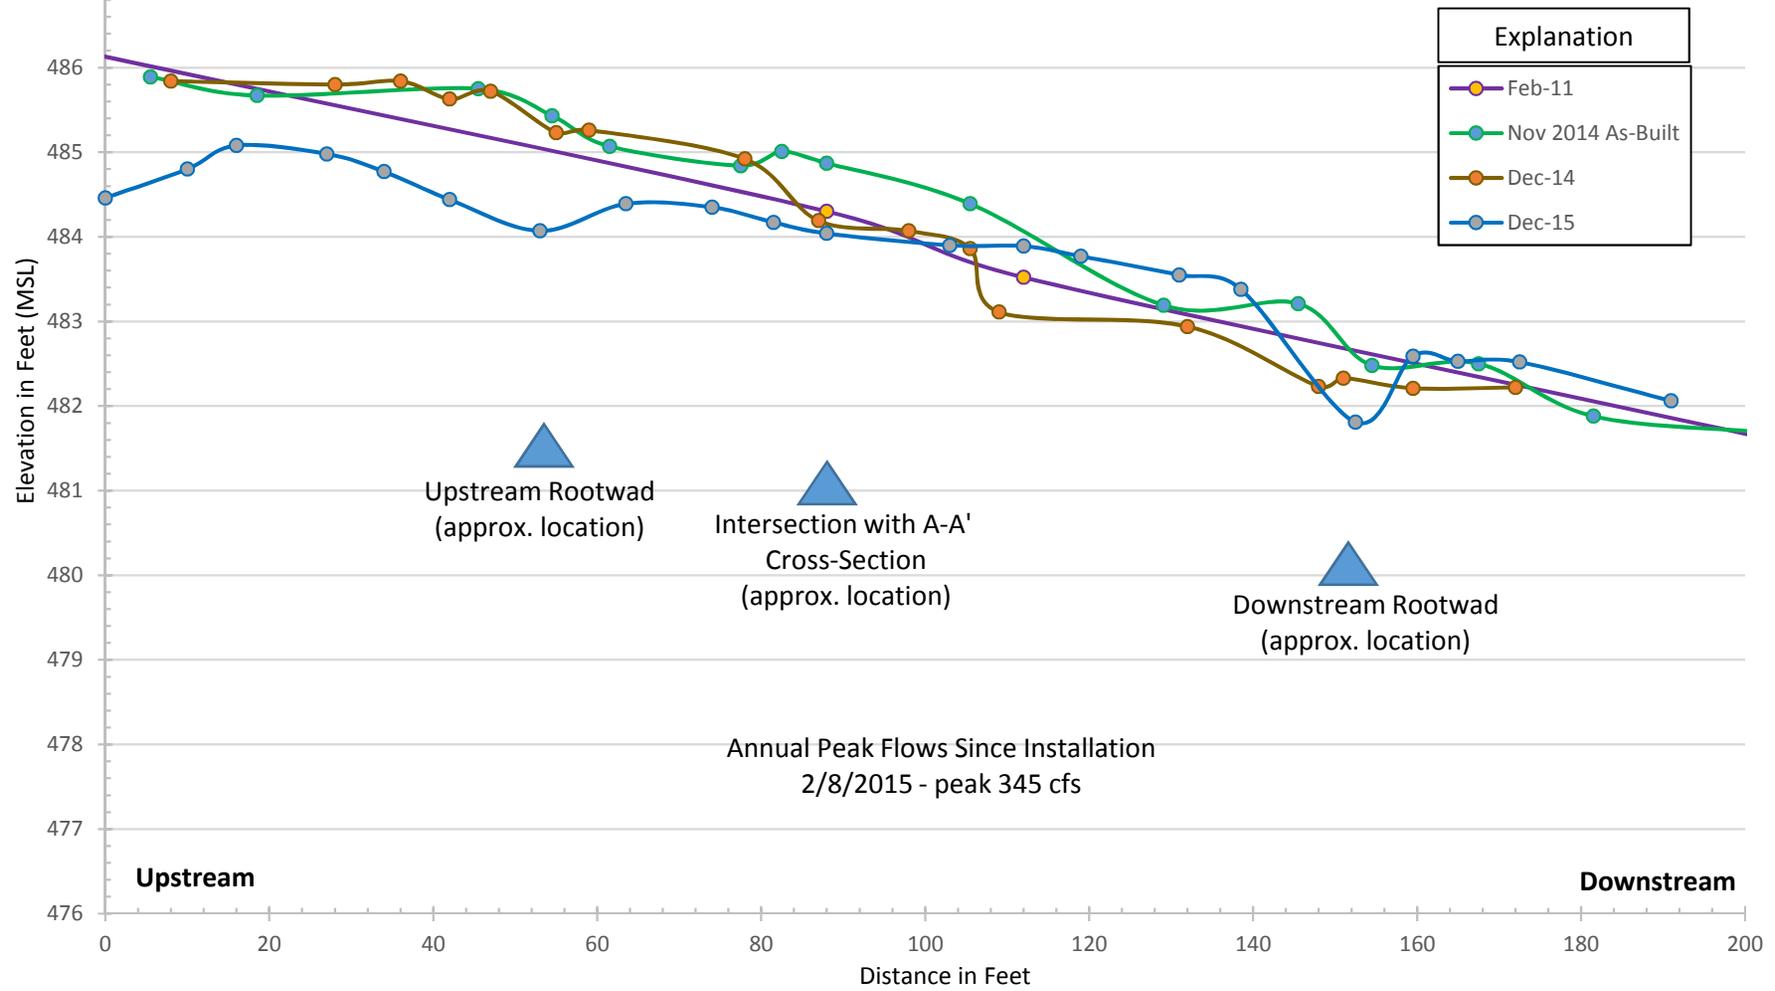
Figure 7: Streambank/Road Repair Thalweg Profile

November 2014 As-Built and December 2014 Surveys. Thalweg surveys were conducted in November 2014 for the post-installation As-Built documentation and again in December 2014 as part of the monitoring event for the large wood sites, though it was not considered a monitoring event for this site. At the time of installation, the thalweg was re-constructed at a relatively uniform two percent grade downstream along the left bank, at the edge of the rootwads, similar to the original pre-construction thalweg position and gradient. Therefore, the post-installation channel bed appears fairly uniform. Thalweg readjustment appears to have taken place in the form of up to approximately a foot of scour downstream of the A-A' cross-section location, forming a stepped morphology.

December 2015 Survey. Within the year after installation, the Road/Bank Repair site experienced an approximately 1.7-year return interval storm event that appears to have caused up to approximately 1 ½ feet of scour upstream of the A-A' cross-section line and some localized aggradation downstream. Two incipient pools (0.32 and 0.78 feet deep) have formed within the project reach and one incipient pool (minimum depth of 0.62 feet) was logged approximately 50 feet upstream of the farthest upstream rootwad location. Although not observable in the thalweg survey, the thalweg has been pushed out toward the center of the channel and finer sandy sediments have been deposited behind the rootwads. These channel changes are represented in Figure 7.

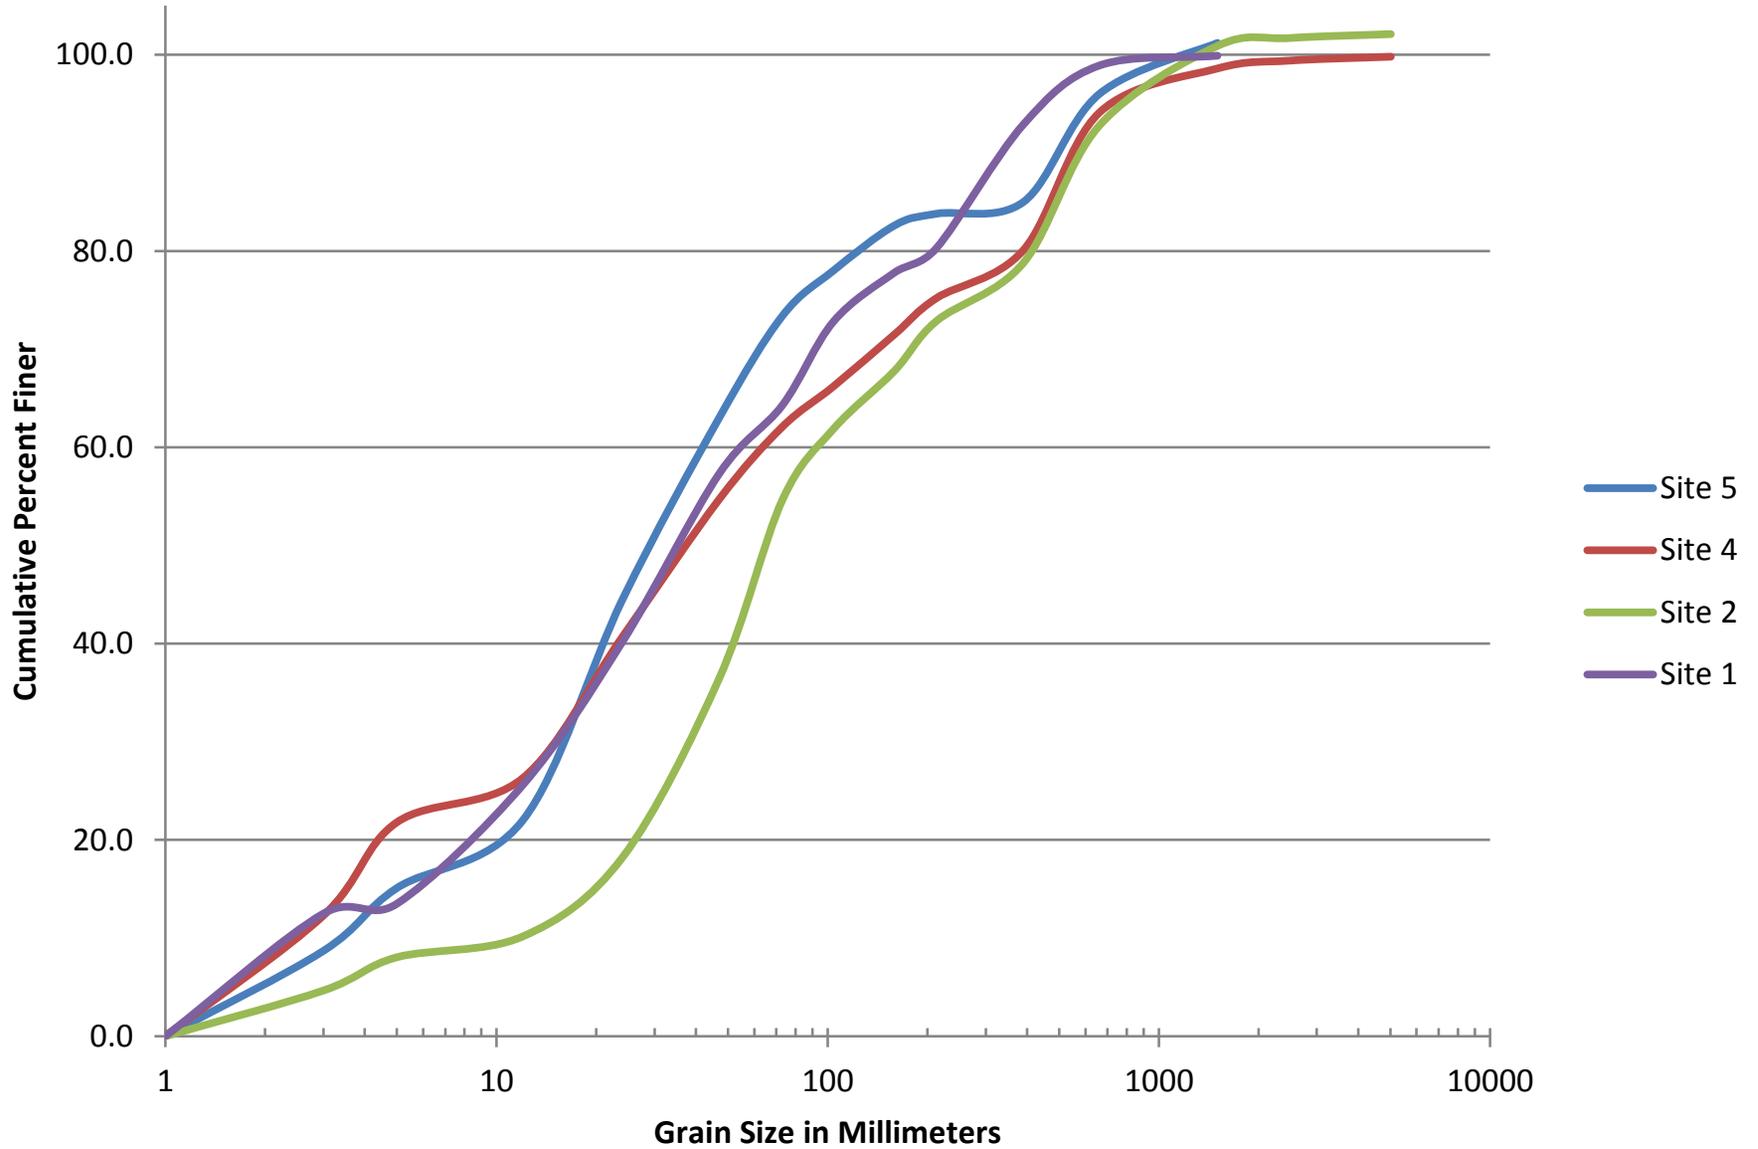
Figure 8: Cumulative Percent Finer Pebble Count Grain Size Distribution

Pebble count data is obtained to conduct comparison of changes to the size of bed materials at each site (1, 2, 4 and 5) over time. Currently there is only one measurement at each site (collected in October 2013) and therefore comparisons cannot be made. The pebble count was conducted in a "Z" configuration through the majority of each reach. The initial pebble count data are provided in graphic form as Figures 8 and 9. Based on the initial data it appears all four sites are gravel dominated (2 millimeters to <64 millimeters) with boulders (over 256 millimeters) comprising the next major component of the streambed particle size. The exception is Site 4 which appears to have a significant sand component (<2 millimeters). Comparatively it appears that Site 2 contains the coarsest substrate, Site 5 appears to have a somewhat finer gravel component, and Site 4 contains more of a sand component. The particle size classification is based on the Wentworth scale (Wentworth, 1922).
