## ANALYSIS OF BIODETERIORATION IN TIMBERS IN 50 YEAR OLD BARN AT JACKSON STATE FOREST

John R. Shelly

Report No. 35.04.183

May 1990

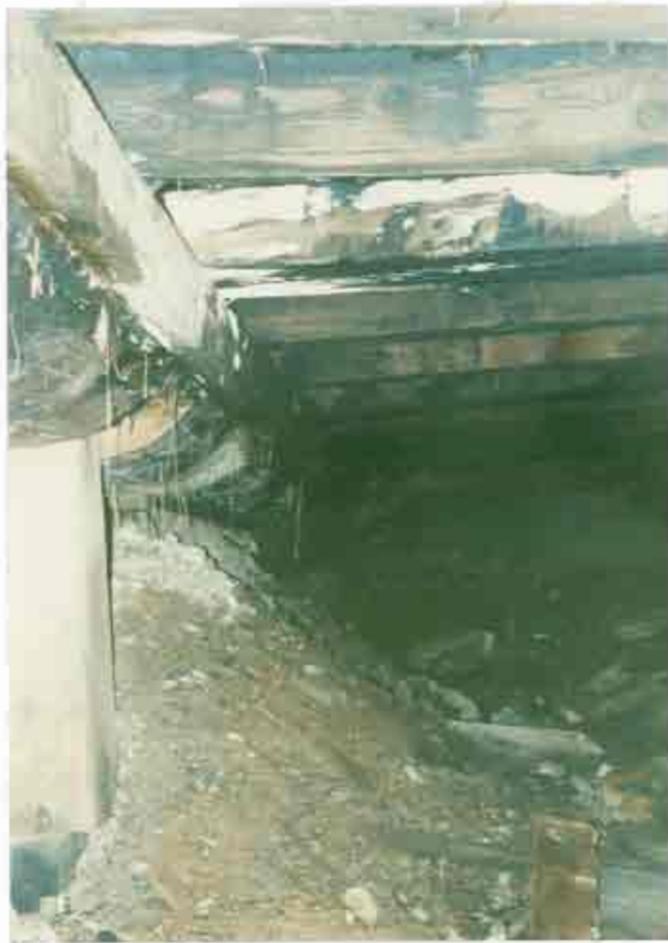
The floor of the gantry bay is supported by a system of wood piers (along lines B, C, D, E, F, and G in Figure 5) and girders (*Figure 6*). This area is at a lower elevation than the two wings; it was apparently dug out to provide access beneath the floor. All of the piers are in direct contact with the ground and were found to be severely decayed at the ground line when sounded with the geologist's hammer.

*Figure 6.* - Substructure of gantry bay showing pier B7 supporting girder B1-B9 and floor boards.

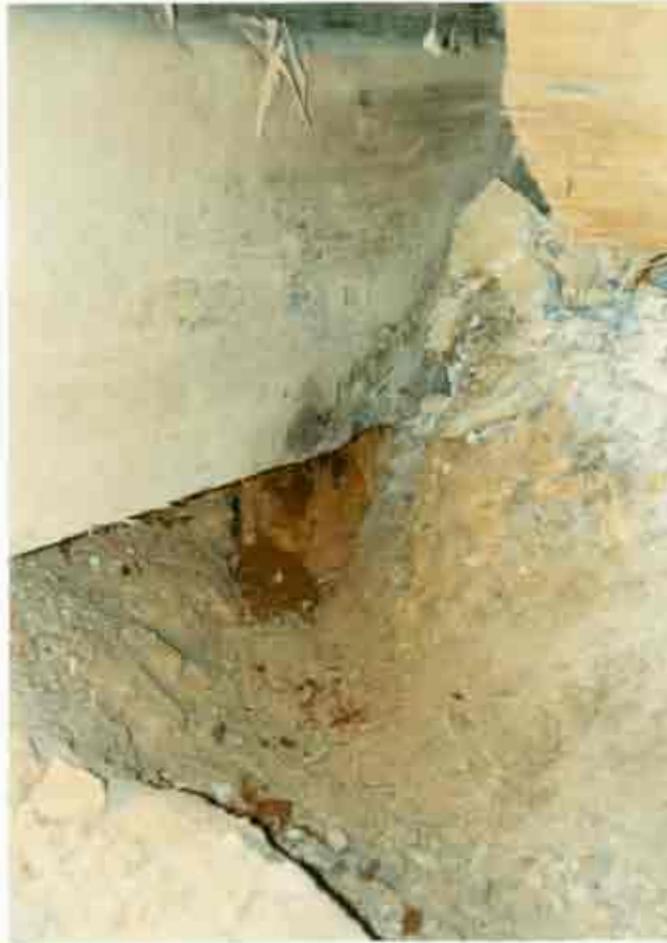
Seven of the 30 piers were cored to a depth of 10 inches at the ground line. Three of these seven (piers G5, F5, and E9) had approximately 1 to 2 inches of "semi-sound" wood (section of the core which held together, but the wood was punky) in a shell near the outer circumference of the pier, but the remainder of the core was completely decayed (*Figures 7 and 8*). The remaining 4 cored piers (D9, F7, G7, and G9) were completely decayed at the ground line (*Figures 9, 10 and 11*).

*Figure 7. - Pier G5 supporting girder B5-G5.*

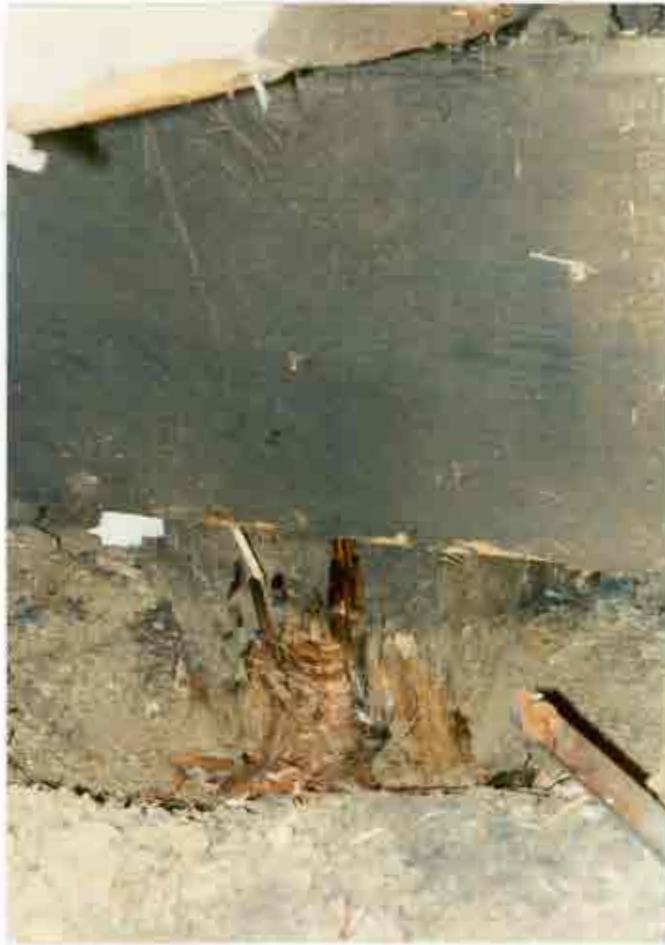
*Figure 8. - Pier F5 supporting girder B5-G5.*

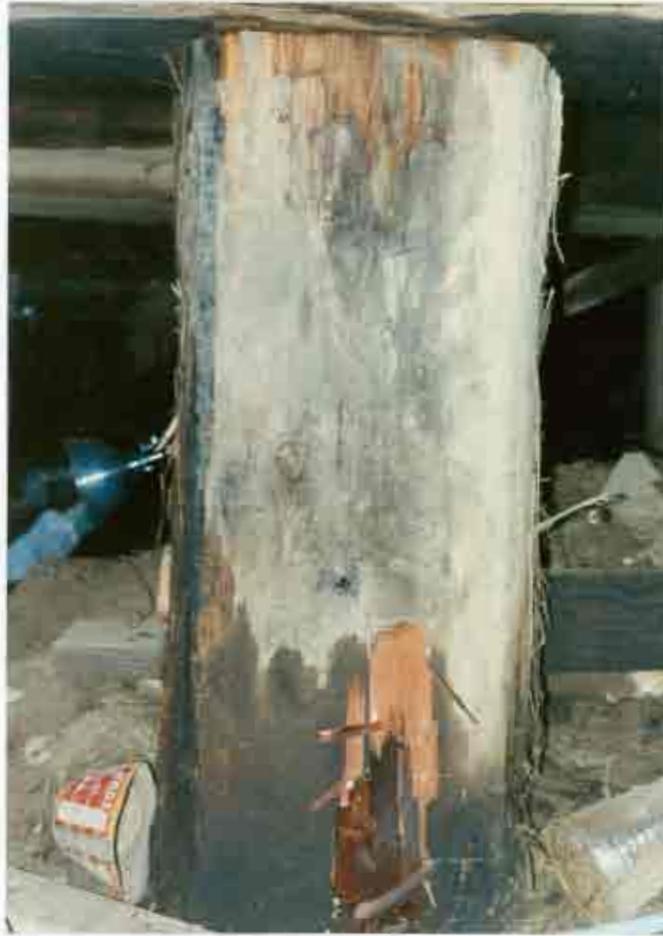
*Figure 9. - Pier F7 supporting girder B7-G7.*

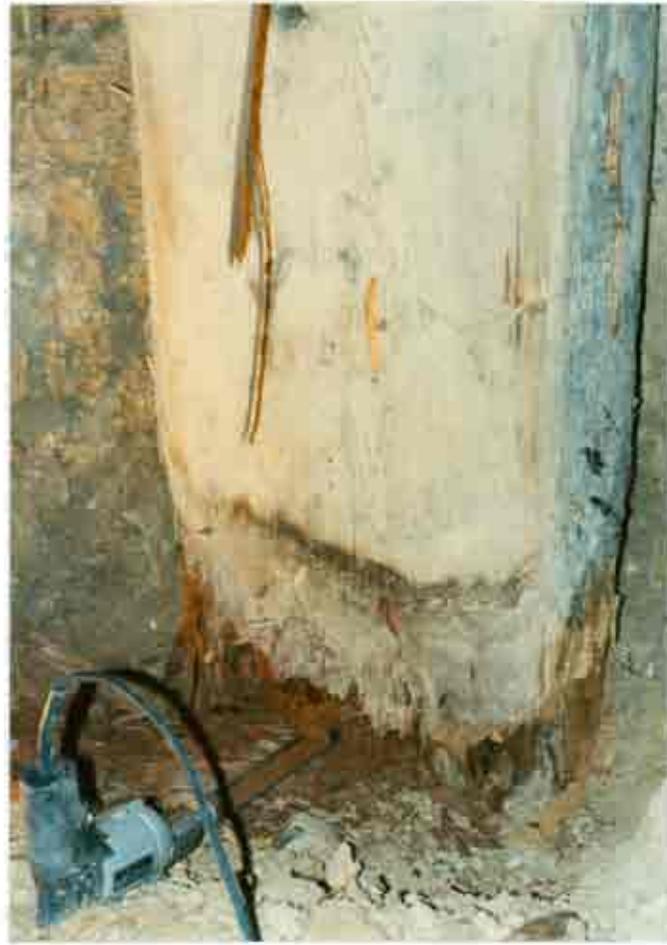
*Figure 10. - Pier G7 supporting girder B7-G7.*

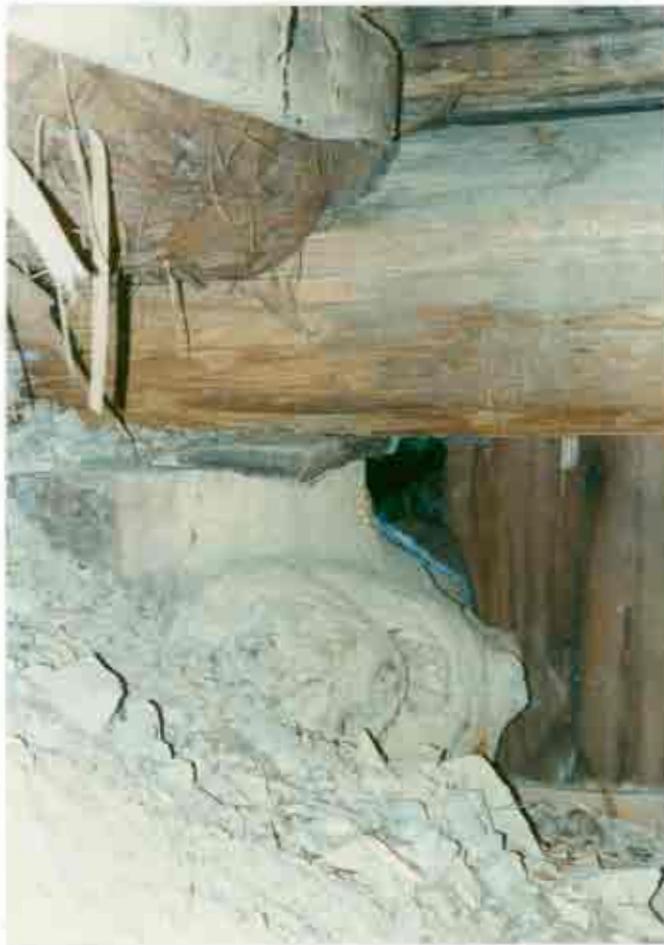
*Figure 11. - Pier G9 supporting girders G1-G9 and B9-G9.*

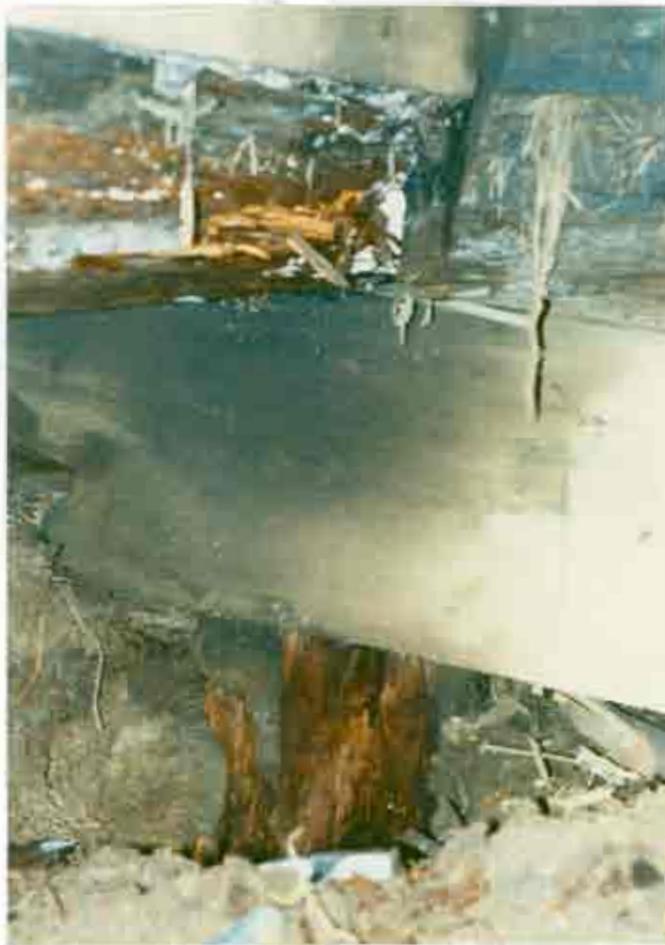
The piers supporting girders B5-G5 and G1-G9 and pier B3 are at least in partial ground contact along their entire length and as a result are decayed along the entire length (*Figure 12*). The remainder of the piers in the substructure have a decay zone extending approximately 12 to 20 inches above the ground with the rest of the above-grade length of the pier being relatively sound. For example, a 10 inch core removed 12 inches above the ground line in pier B9 was sound along its entire length.

*Figure 12. - Pier D5 supporting girder B5-G5, note advanced decay along entire length of pier.*

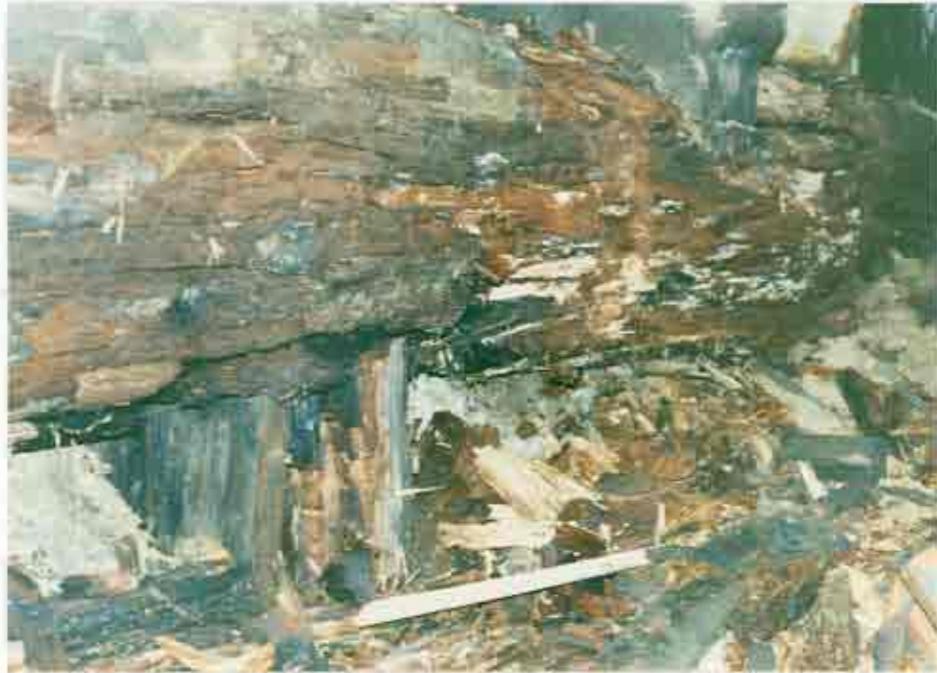
Girders B1-B9, B9-G9 and G1-G9 support most of the barn superstructure. Girder B1-B9 has zones of advanced decay along its entire length and is in danger of failing completely (*Figure 13*). Girder G1-G9 has some pockets of decay but is remarkably sound along most of its length. Girder B9-G9 is decayed and infested with drywood termites and is in danger of failing; approximately 80% of the top half of the girder is completely deteriorated (*Figures 14 and 15*). There did not appear to be a girder along B1-G1; the main columns B1 and G1 are in direct ground contact.

*Figure 13.* - Section of girder B1-B9 at pier B3, showing advanced decay in both girder and pier.

The western end of girder B1-B9 is in direct ground contact and as a result is severely decayed and in danger of immediate failure.

Girder B1-B9 and the gantry and roof columns it supports must be adequately shored before work is done on the roof. Shoring of the gantry floor and lateral bracing of the west end is also needed. These shoring and repair recommendations are not to be taken as comprehensive; additional evaluation of the building shoring needs should be done by qualified design and construction professionals.

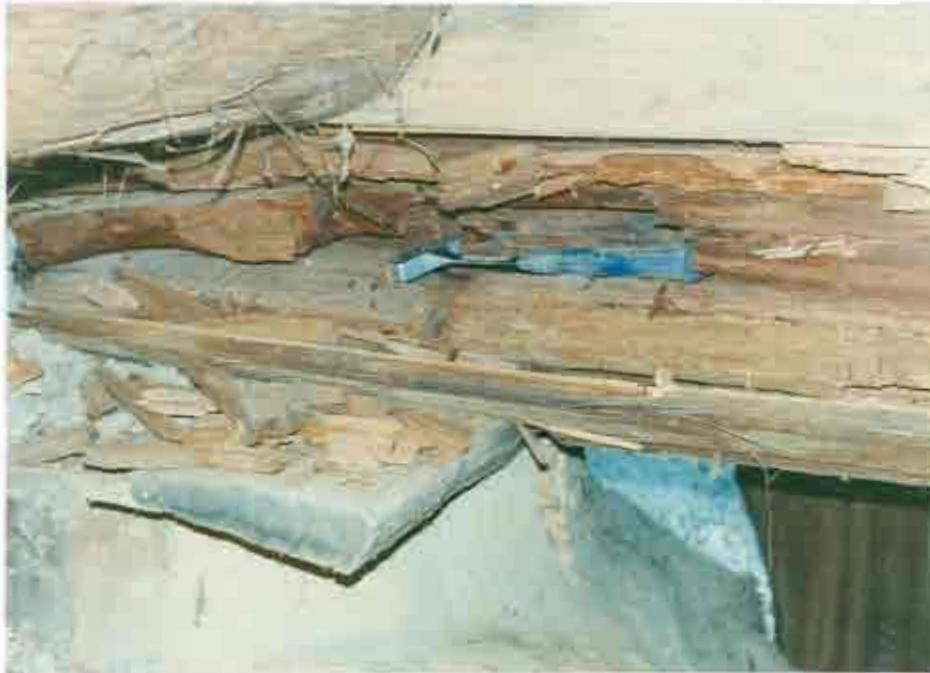
*Figure 14.* - Section of girder B9-G9 at pier G9 in the substructure area, showing the location of advanced decay.

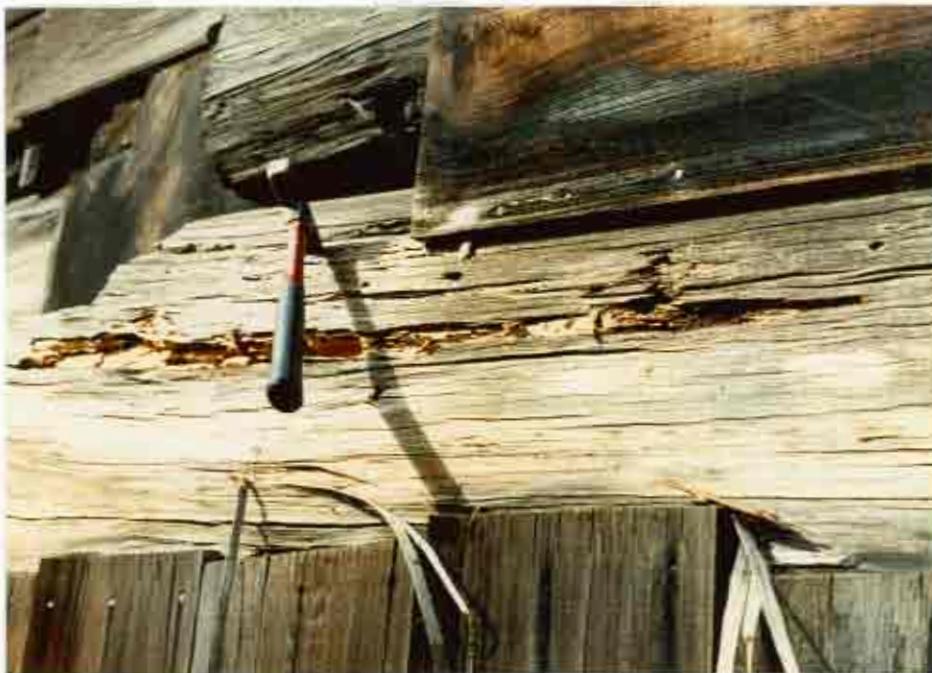
*Figure 15.* - Area of drywood termite infestation in the exterior portion of girder B9-G9.

The damage caused by the drywood termites in girder B9-G9 is extensive. This girder also has extensive decay damage and is not considered salvageable.

Long term control of the wood-destroying insects is difficult if not impossible in a forest setting. Replacement of infested wood or periodic spot treatment with an approved insecticide will probably be as effective as a more intensive method such as whole structure fumigation.

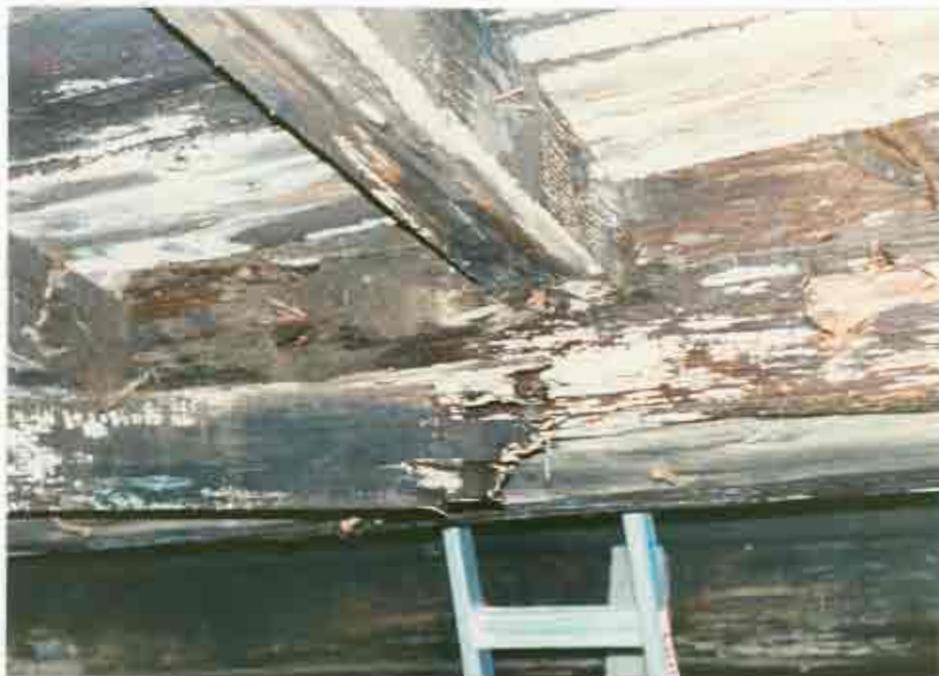
The wood members in the southeast corner of the gantry bay substructure are wet (moisture contents above 30%) and supporting an active colony of decay fungi. Mycelia were readily apparent on the underside of the girders, joists and floor boards (Figures 16 and 17).

*Figure 16.* - Fungal mycelia on floor joists and floor boards in the southeast corner of substructure area.

*Figure 17.* - Fungal mycelia on floor joists and floor boards in southeast corner of substructure area.

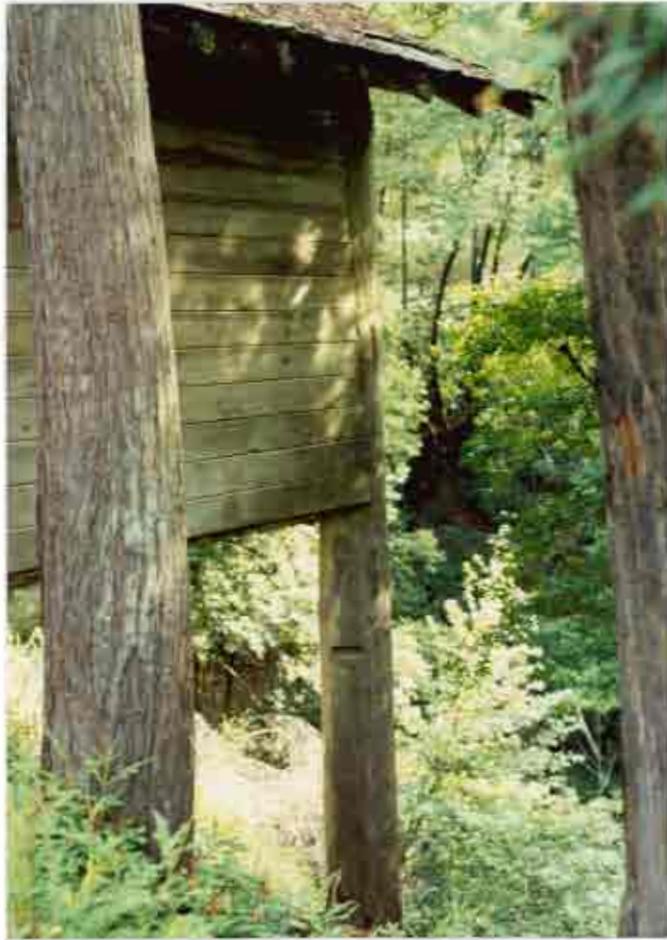
The southeast corner of the south wing is elevated because of the sloping creek bank (Figure 18). This corner is supported by columns A6, B6, B9, and A9 and beams A6-B6, B6-B9, B9-A9, A9-A6. Columns B6 and B9 were examined from the gantry bay substructure and their condition as piers was discussed above. Both are decayed at the ground line but the remainder of the above ground section is sound. Column A6 (Figure 19) had a semi-sound shell of 3 inches with the remainder of the 10 inch core completely decayed. Column A9 was cored from the down-slope side starting approximately 6" above ground and cored horizontally so that the end of the core was below ground level at the up-slope side. The core removed from this column was sound for the first 8 inches with the remainder being completely decayed. This core indicated that the above ground section is sound whereas the wood at and below the ground line is decayed; an observation consistent with results of the other ground contact vertical members in the barn.

*Figure 18* - Elevated southeast corner of the south wing at column (pole) A9.

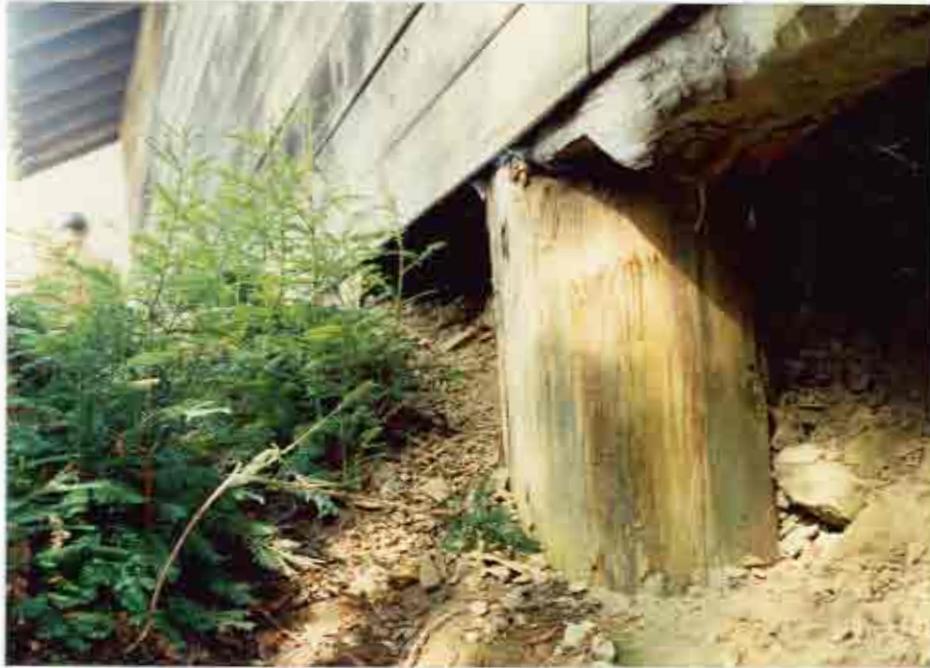
*Figure 19.* - Column A6 of south wing supporting beam A6-A9.

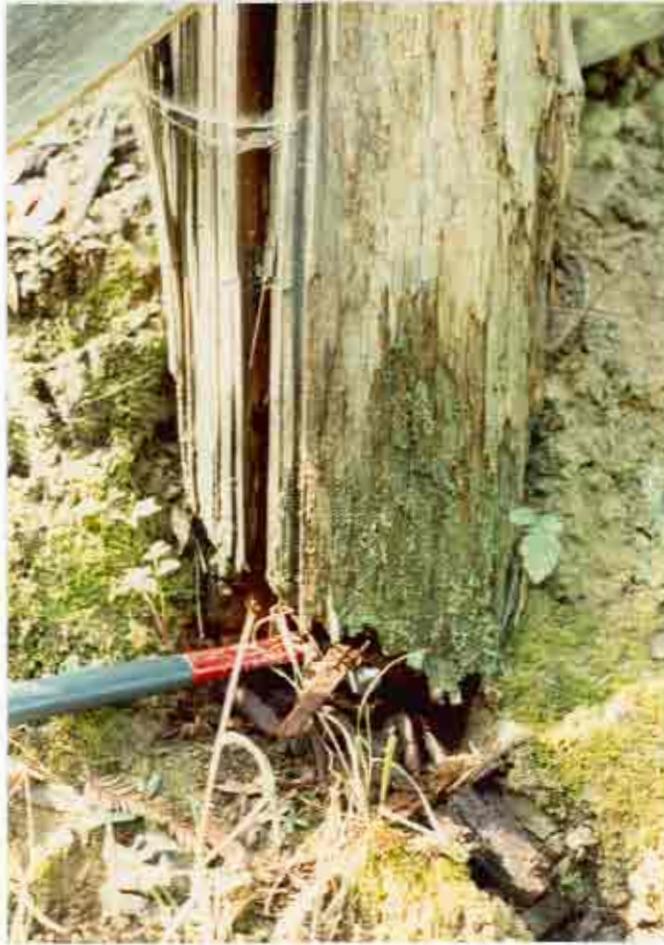
points in Figure 5). The columns are severely decayed along their entire length with near complete decay at the ground line (*Figure 21*). The girders are badly decayed and currently infested with wood-boring beetles (*Figure 22*).

*Figure 21.* - Advanced decay in pier G.7/10 supporting the northeast corner of the shed.

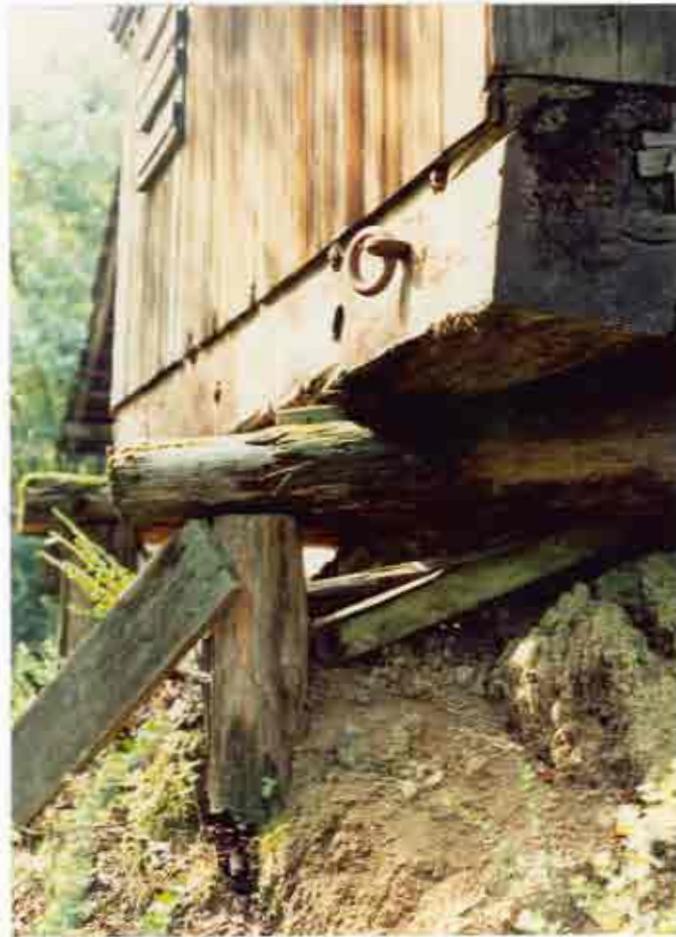
*Figure 22.* - Pier and girder frame supporting the northeast corner of the shed.

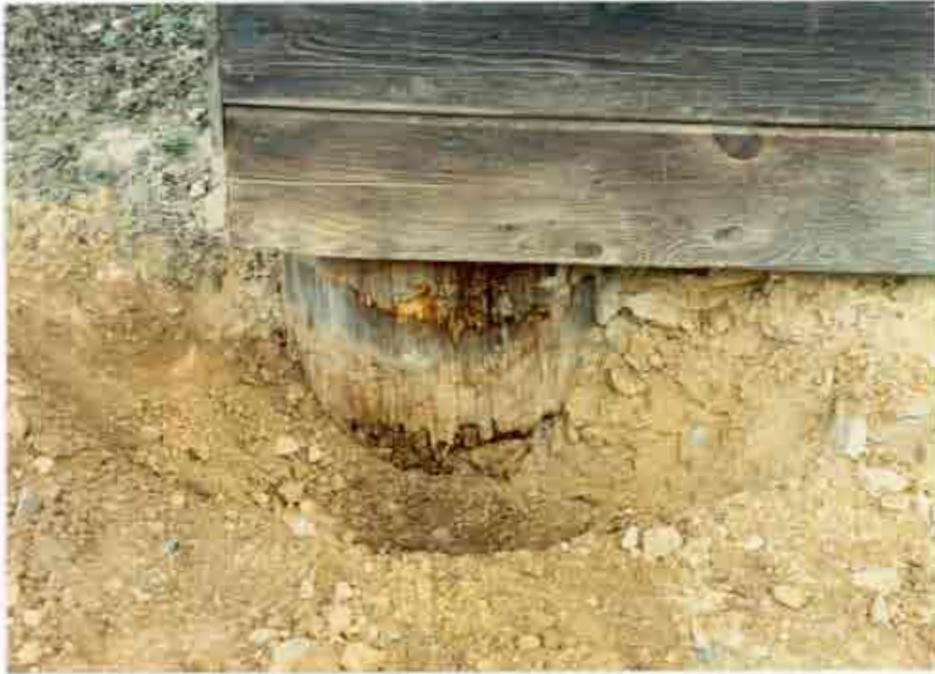
The north and south exterior walls of the side wings of the barn are a pole type construction. A series of vertical columns (poles), which are embedded into the ground, provide the foundation and main structural support for these walls. Columns A1, A4, A6 and A9 support the south exterior wall. The condition of columns A6 and A9 were discussed above, as part of the support of the elevated southeast corner. Column A1 was completely decayed at the ground line (*Figure 23*), but the core removed from the ground line zone of A4 did not reveal any evidence of advanced decay in the heartwood zone (the outer shell of sapwood is totally deteriorated) (*Figure 24*).

*Figure 23.* - Advanced decay in column A1 at the southwest corner of the south wing.

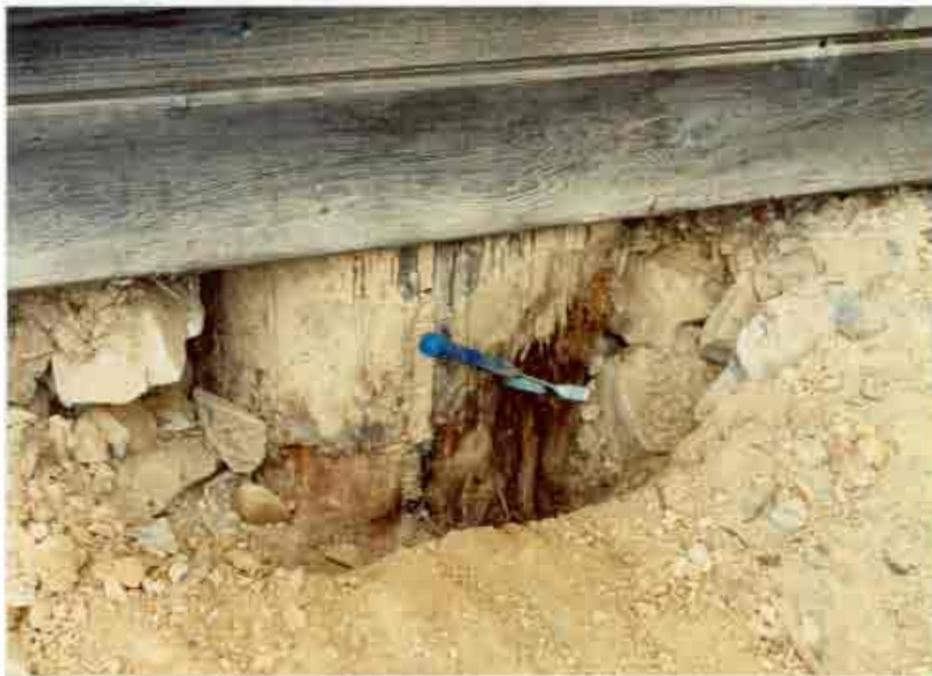
*Figure 24.* - Column A4 of the south wall of the south wing.

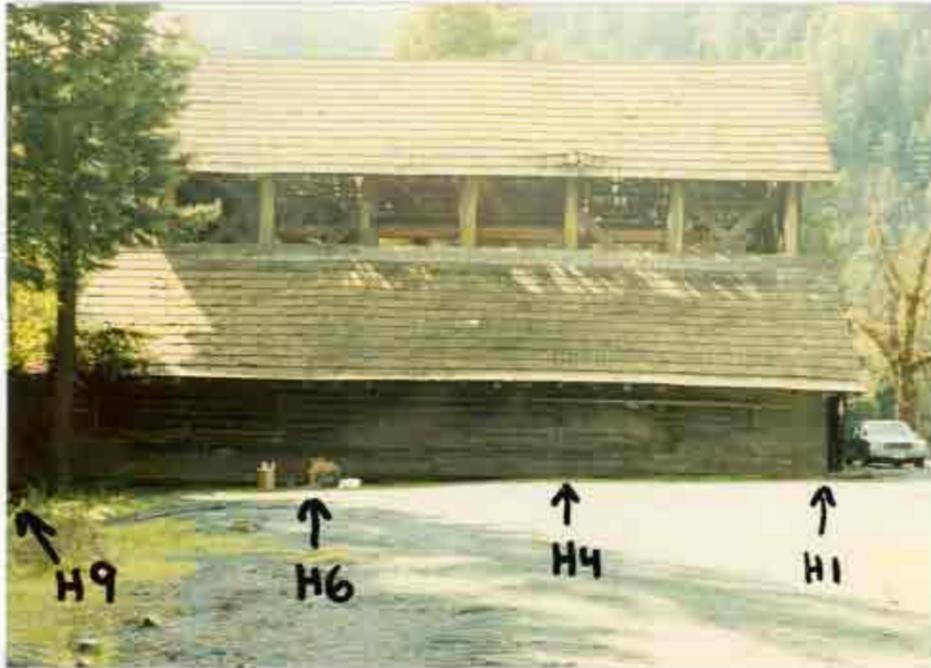
The columns along the north wall have varying degrees of decay at the ground line (*Figure 25*). Column H1 is completely decayed at the ground line. The 10 inch core removed from the ground line of H4 did not reveal any evidence of advanced decay, although incipient decay was likely. In column H6, the outer 3 inches were completely decayed but the inner core was semi-sound. In column H9, incipient decay was evident in the outer 9 inches and the center of the pole was completely decayed. As with the other vertical members inspected, the advanced decay does not extend very far above the ground line.

Figure 25. - North side of the barn showing the location of the columns supporting the north wall of the north wing.

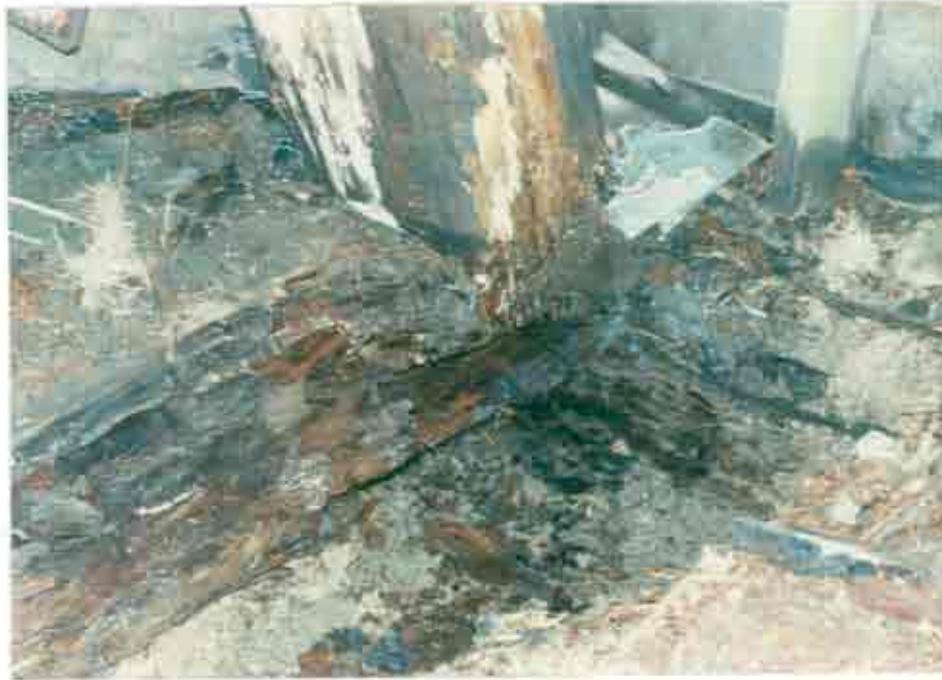
Column B1 has advanced decay in the bottom 2 feet of the pole (*Figure 27*). Columns B2, B4 and B5 have a sound outer shell (outer 2 inches) but the inner core is completely decayed at a location 6 inches above the bottom end. Columns B6 and B8 and B9 (*Figure 28*) did not exhibit any evidence of decay along the entire length of the poles.

*Figure 27.* - Southwest corner of the gantry bay showing column B1 bearing on girder B1-B9, note the advanced decay in the bottom of the column and the girder.

The decay at the base of roof and gantry columns B1, B2, B4 and B5 is of concern. However these columns may be repairable by using an epoxy consolidation technique or designing a structural connection from the floor girder to the sound wood in the columns.

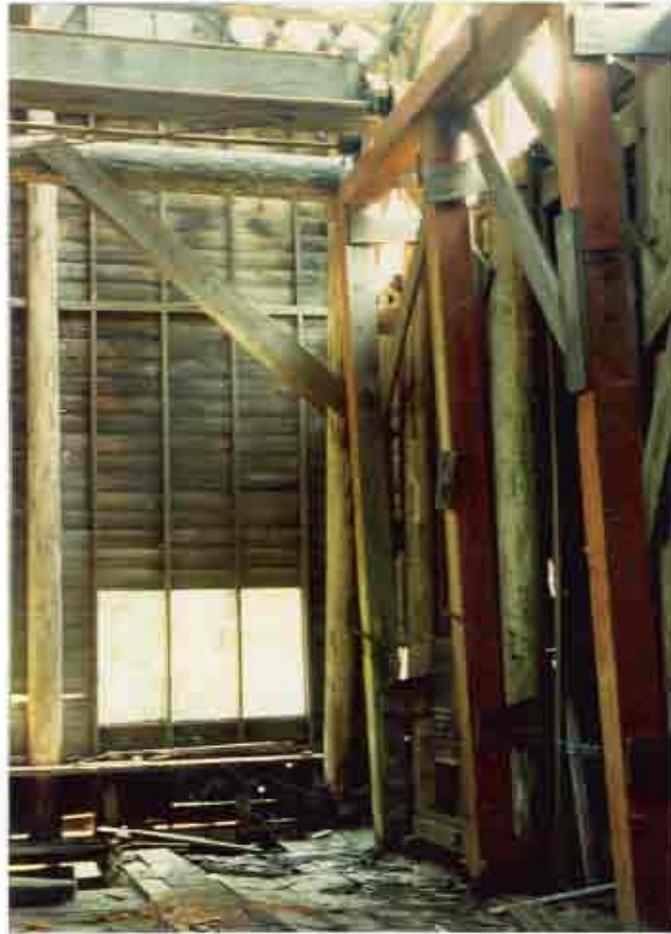
*Figure 28.* - Interior view of the southeast corner of the gantry bay.

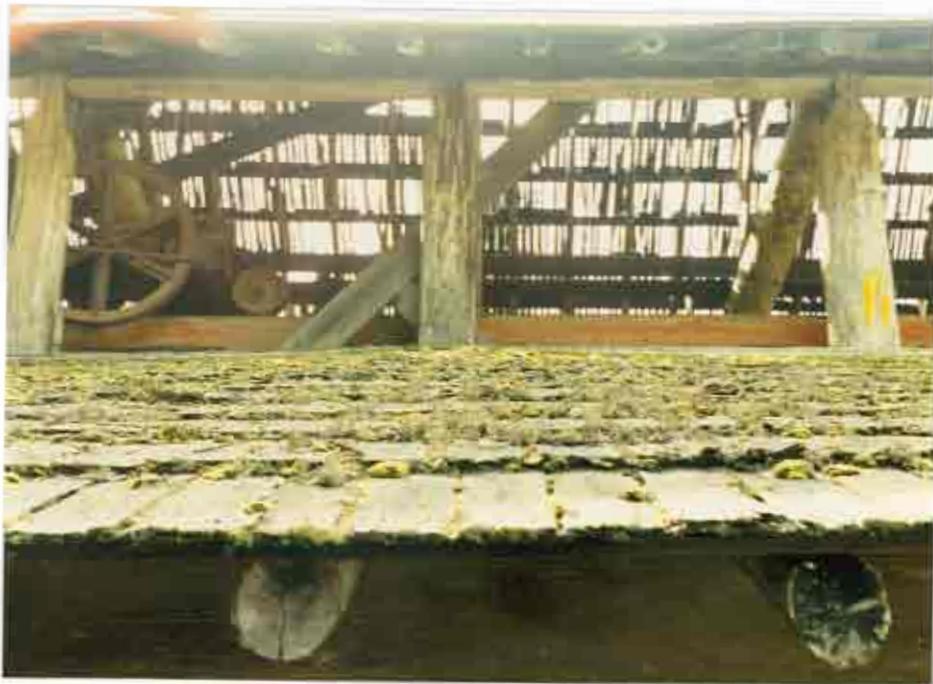
Nearly all of the shingles on the south side of the roof are missing (*Figure 30*), however the north side is relatively intact. As a result, deterioration is greater on the south side of the barn. The roof beams all show major deterioration in the southern half of the gantry bay.

*Figure 30.* - View of the south roof of the gantry bay as seen through the open north side wall (roof in foreground is the north wing).

The barn has suffered serious biological deterioration in many major structural members. It is imperative that the south roof of the gantry bay be repaired to minimize water infiltration into the barn and thus minimize future decay. Unfortunately the roof cannot be repaired until the roof beams are replaced, or at the least thoroughly shored and braced. The condition of the roof joists and spaced sheathing boards could not be assessed, therefore any work on the roof must proceed with caution.

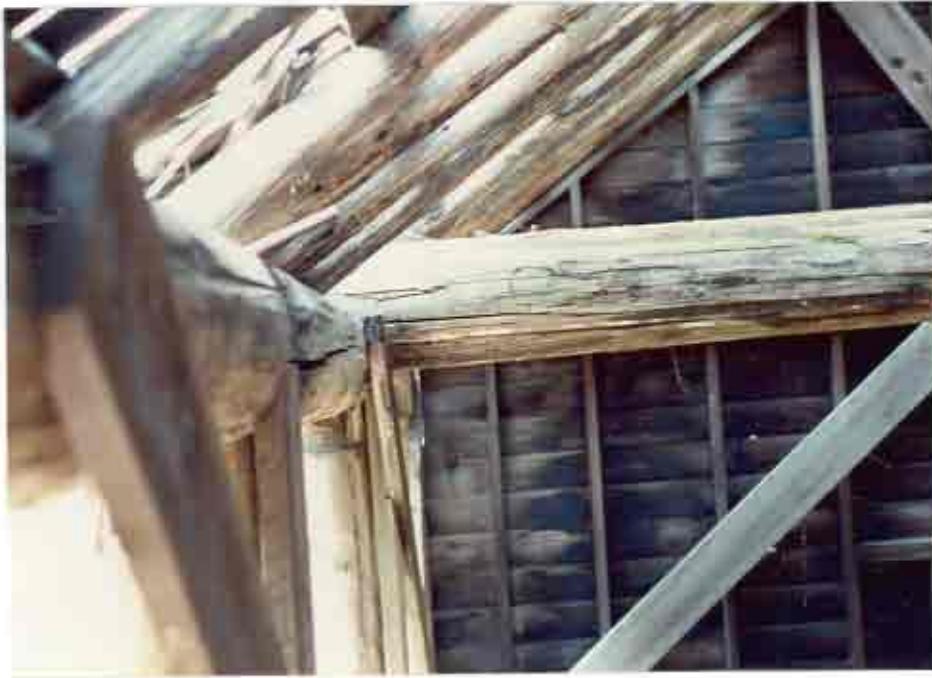
All of the roof beams are considered to be in danger of failing. Beam B2-G2 (*Figure 31*) was only observed from a distance, however the moss and mildew growing on the surface of the beam indicate that favorable conditions exist for decay. This beam also had a horizontal split at the bearing notch which extended approximately 4 feet towards the center. Beam B4-G4 is missing (*Figure 32*); evidence indicated it had failed at an earlier date and had been removed. Beam B5-G5 has advanced decay in the top 5 inches, extending from the bearing notch inward for 3 feet (*Figure 33*) and a split extending from the bearing notch toward mid span. Beam B6-G6 has advanced decay in the top half starting approximately 10 feet from the bearing notch and extending for 4 feet towards the middle of the beam (*Figure 34*). Beam B8-G8 (*Figure 35*) is severely decayed in nearly all of the southern half of the beam and is **in danger of immediate failure**. Roof beams B1-G1 and B9-G9 could not be safely evaluated.

*Figure 31.* - South end of roof beam  
B2-G2 in the gantry bay.

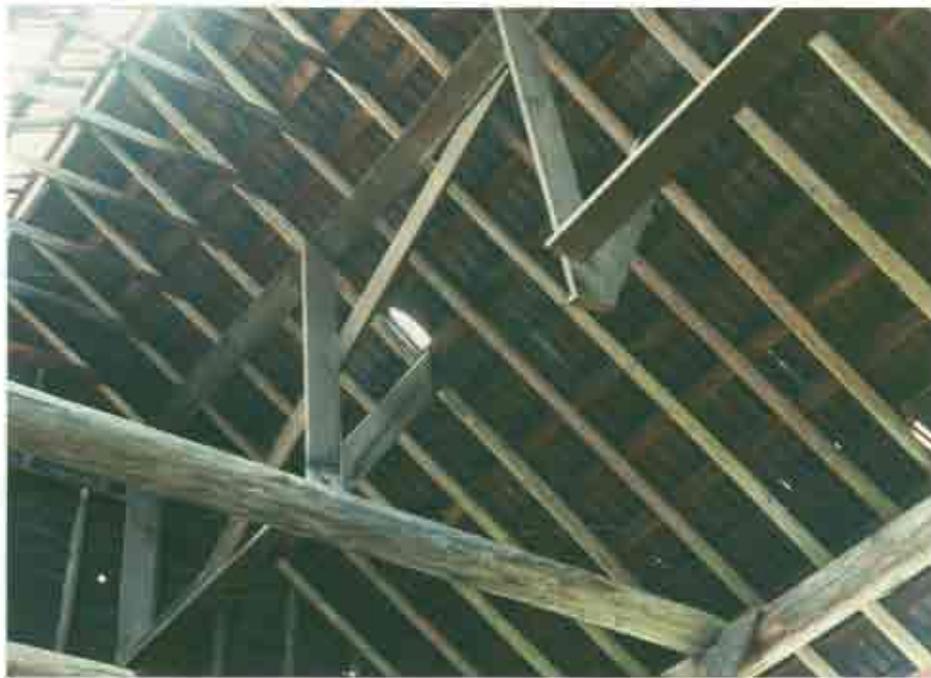
*Figure 32.* - The north roof of the superstructure  
of the gantry bay at the location of  
the missing roof beam B5-G4.

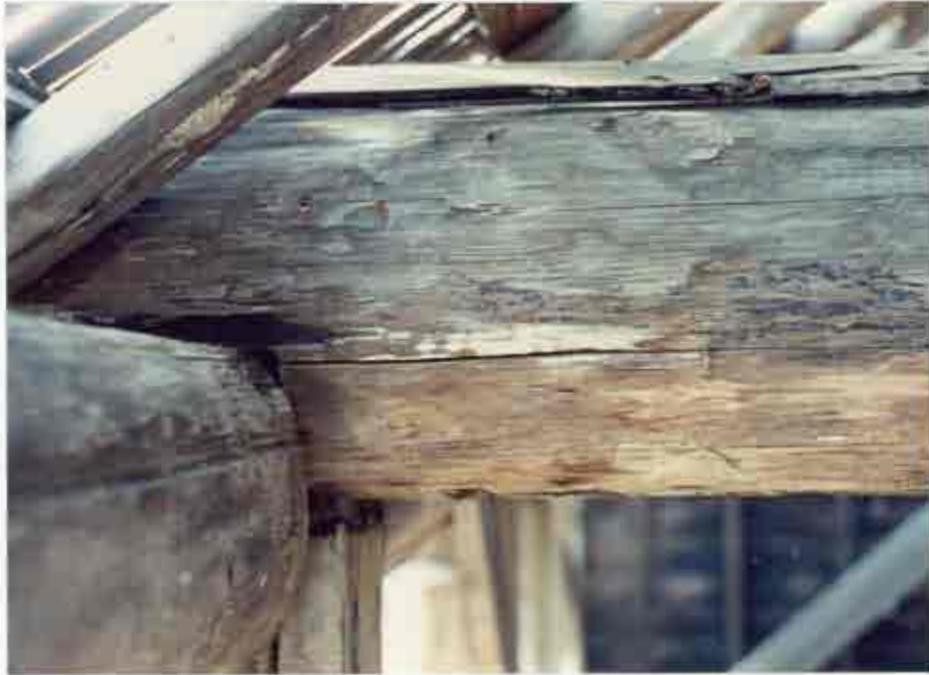
*Figure 33.* - South end of roof beam  
B5-G5 in the gantry bay.

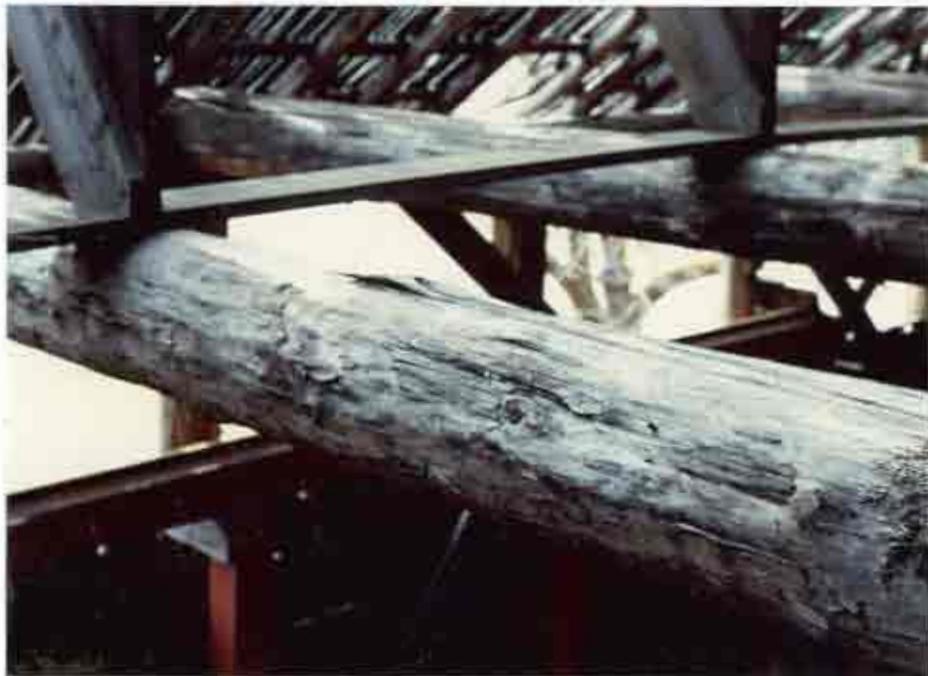
*Figure 34.* - Section of suspected decay in  
roof beam B6-G6 of the gantry bay.

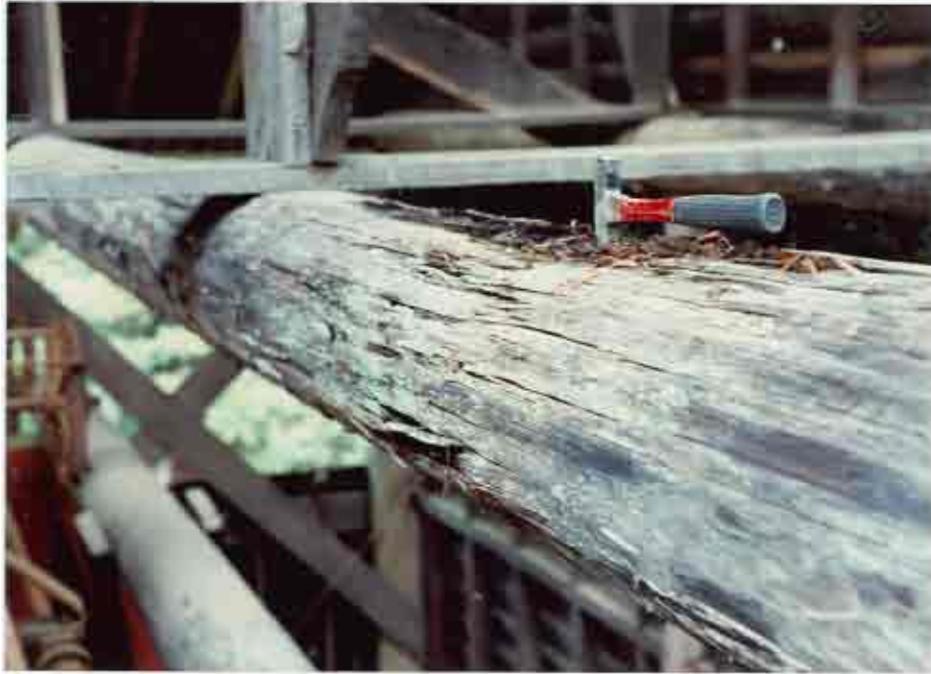
*Figure 35. - Zone of advanced decay in roof beam B8-G8 of the gantry bay.*

The most serious deterioration from a structural point of view is the decay of floor girder B1-B9 and the decay in the roof beams. These members are crucial to the structural integrity of the barn. If the roof is repaired before the next rainy season, then some of the floor girders may be salvageable. However it may take 1 to 2 years for the larger members to dry enough to arrest the decay. The roof beams are considered decayed to a degree that makes them unsalvageable. Roof beam B8-G8 is in danger of immediate failure and the remaining roof beams are also considered unsafe.

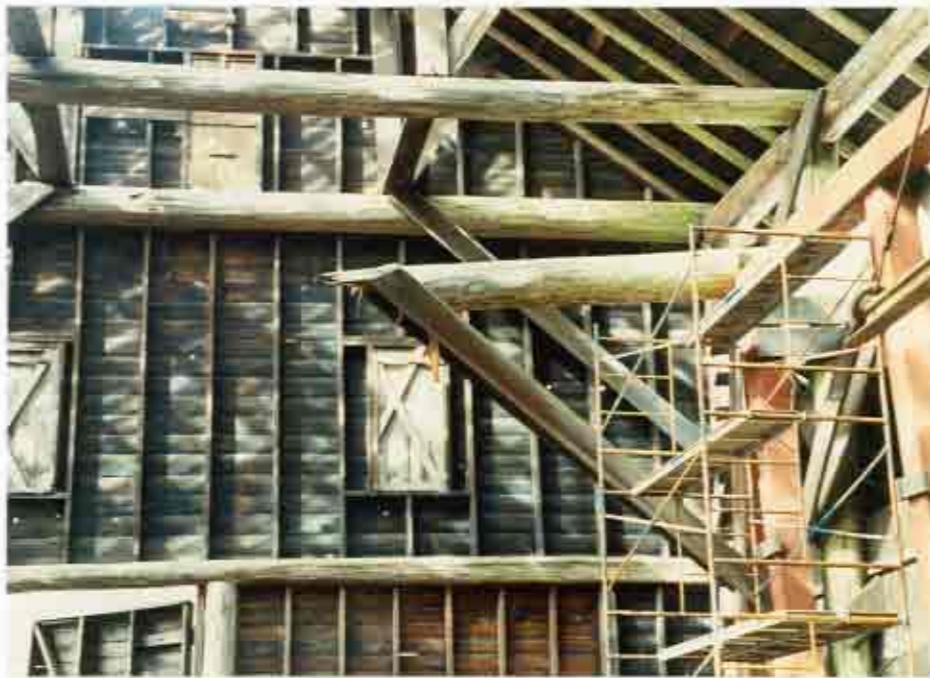
The overhead crane is supported by a frame of large redwood timbers. This gantry frame consists of 5 vertical columns along each side, each side supporting a girder (*Figure 36*). Each side of the gantry frame is connected together by end beams. The gantry beam at the west end failed and was removed at an earlier date (*Figure 37*). The crane was mounted onto a movable carriage that could traverse the gantry along rails on the top girders (*Figure 29*).

*Figure 37.* - Broken gantry end beam at the northwest corner.

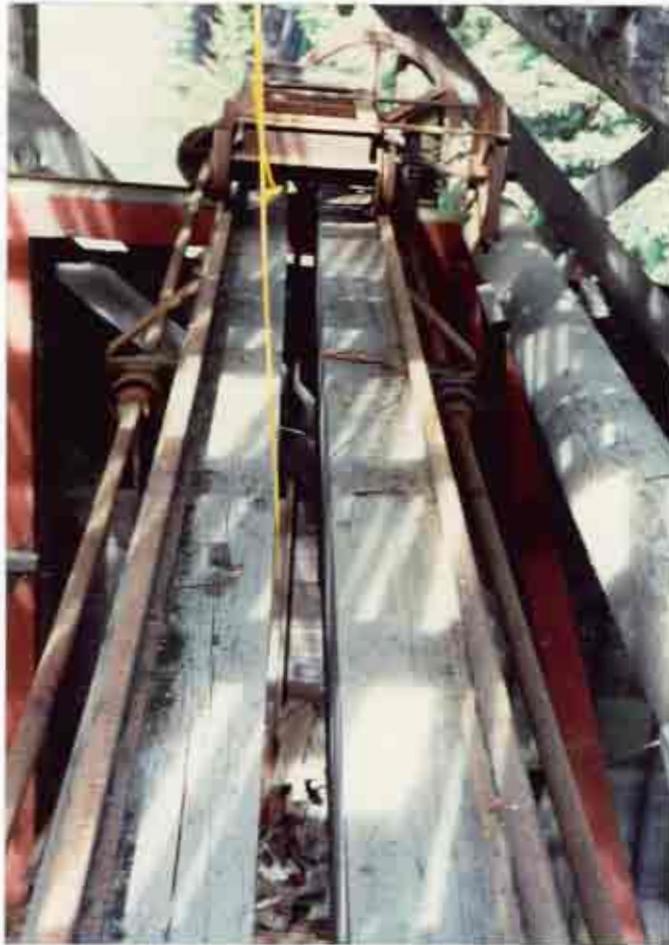
Gantry columns B2 and B4 have evidence of decay in the bottom 6 inches, however no evidence of decay was found in the remainder of the gantry columns. Also the gantry beam at the east end of the gantry does not exhibit any evidence of decay. Of the two main beams that formed the movable carriage for the crane, the easternmost one appeared to be sound but the westernmost one has numerous deep checks and sounding with a hammer indicated possible decay (*Figure 38*).

*Figure 38.* - Double beams of the overhead crane carriage.

The decayed crane carriage beams will probably survive in their present condition. However, if any additional load is applied to the crane or if it is not protected from future rain, then its condition will need to be reevaluated.
