MEMORANDUM

DATE: May 12, 2016

SUBJECT: Soquel Creek Large Woody Debris Habitat Complexity and Streambank/Road Repair Projects, 2015 Annual Physical Monitoring Report

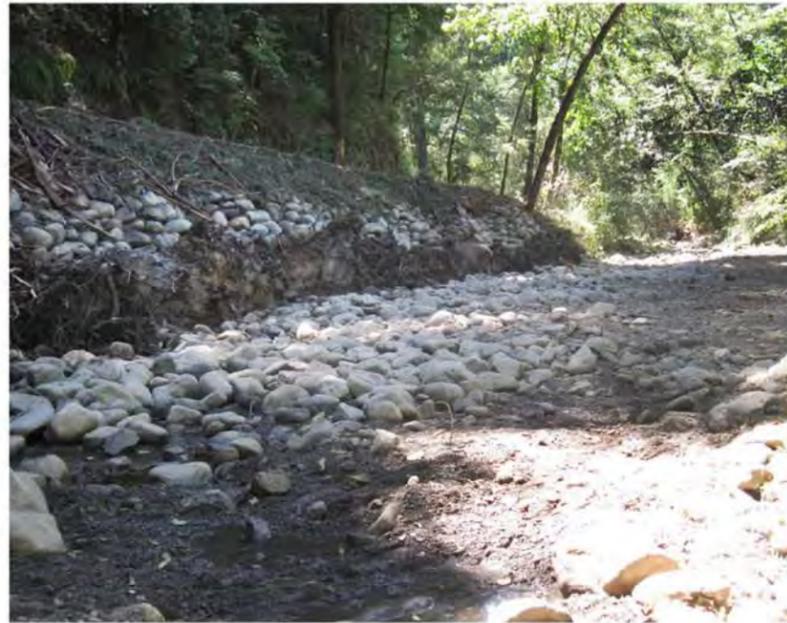
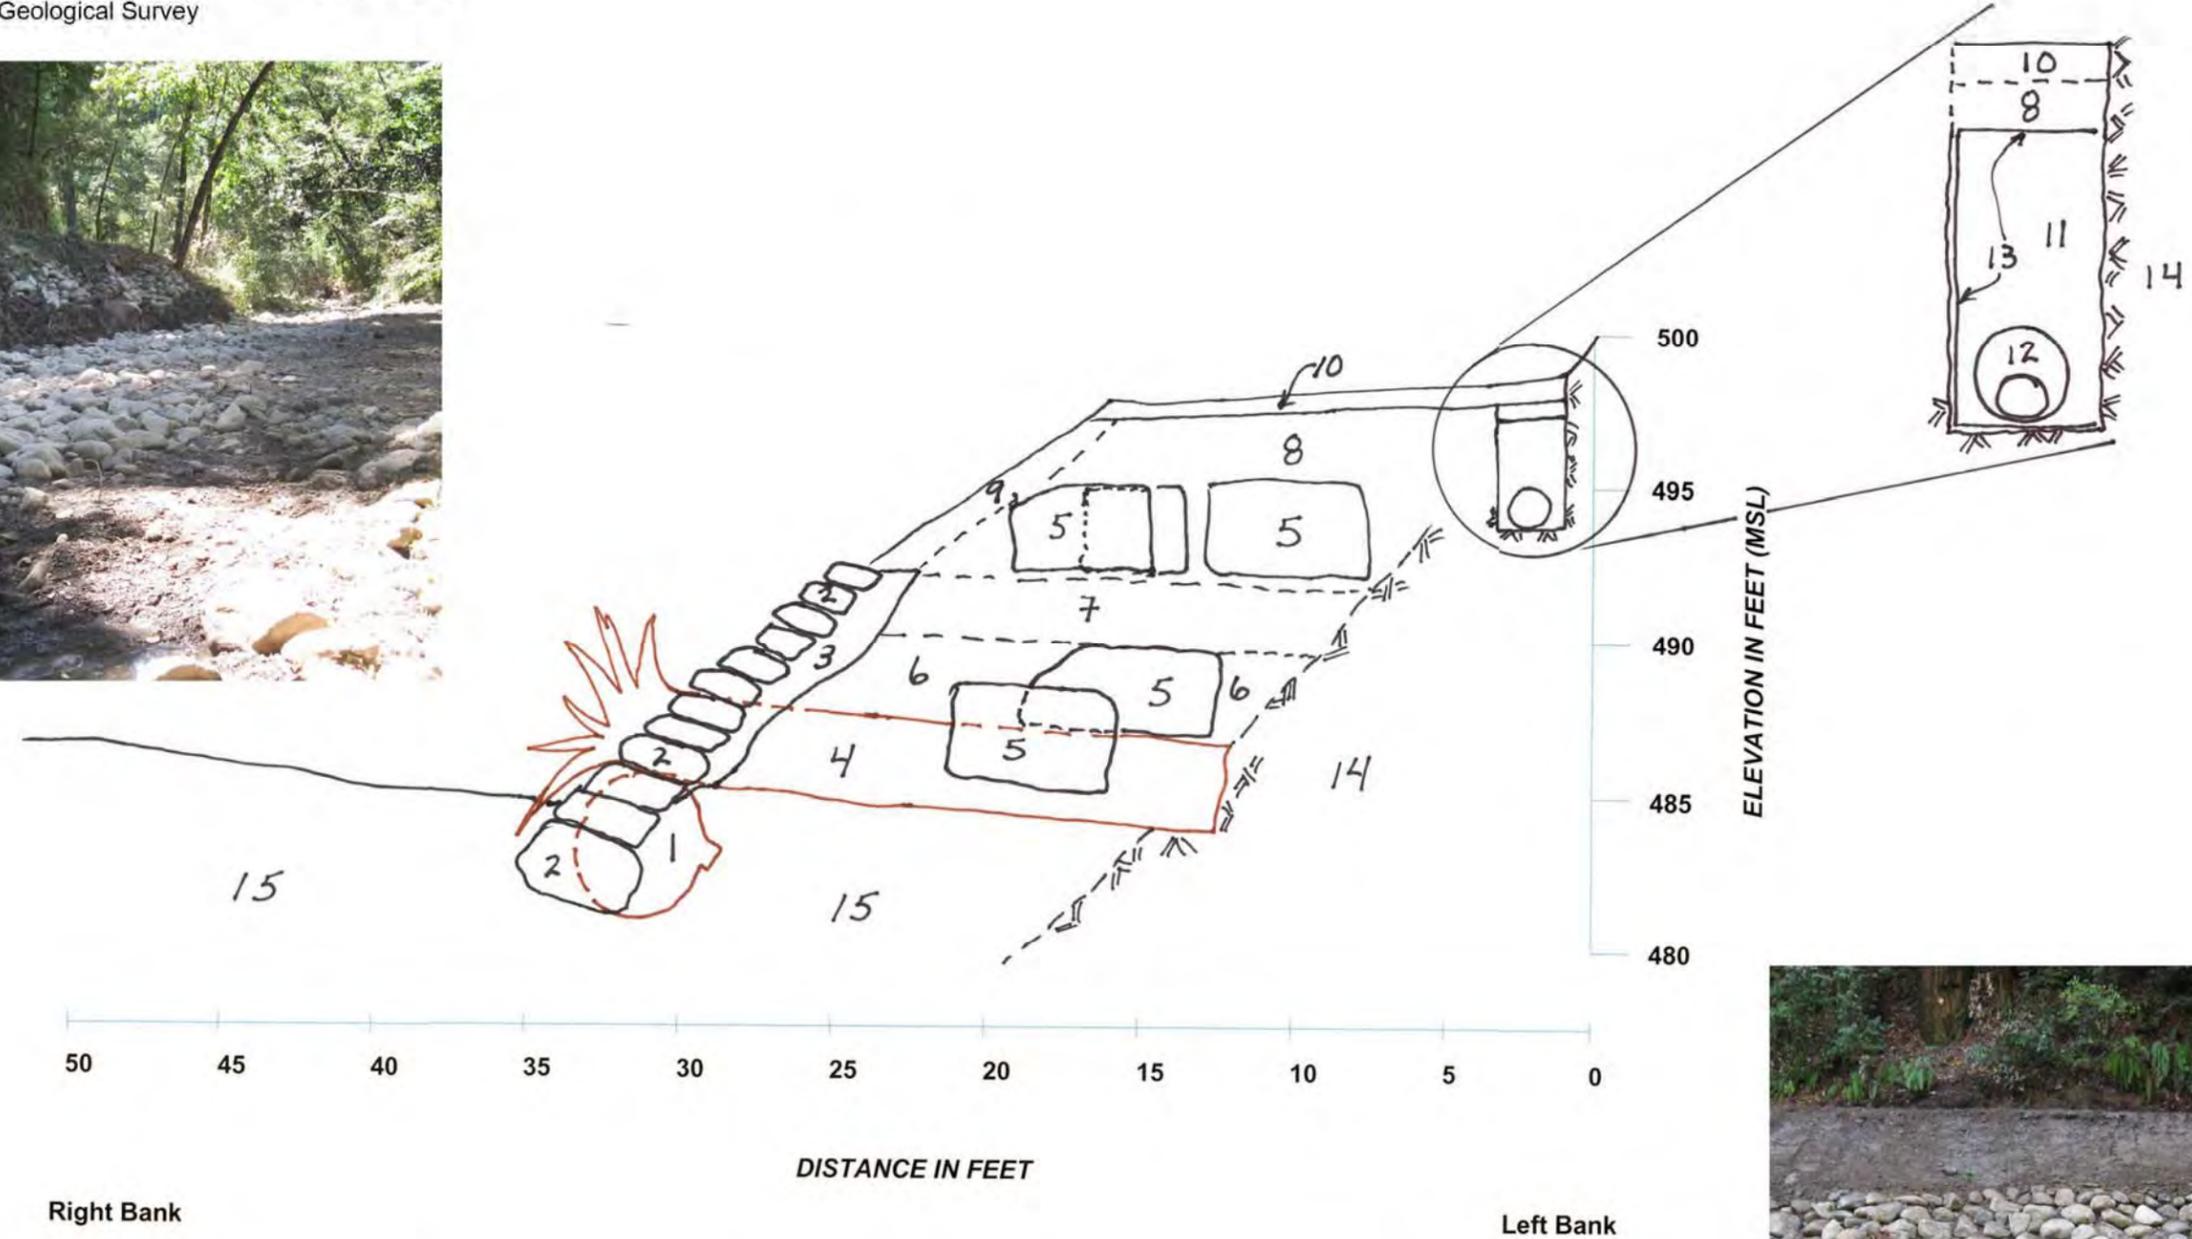
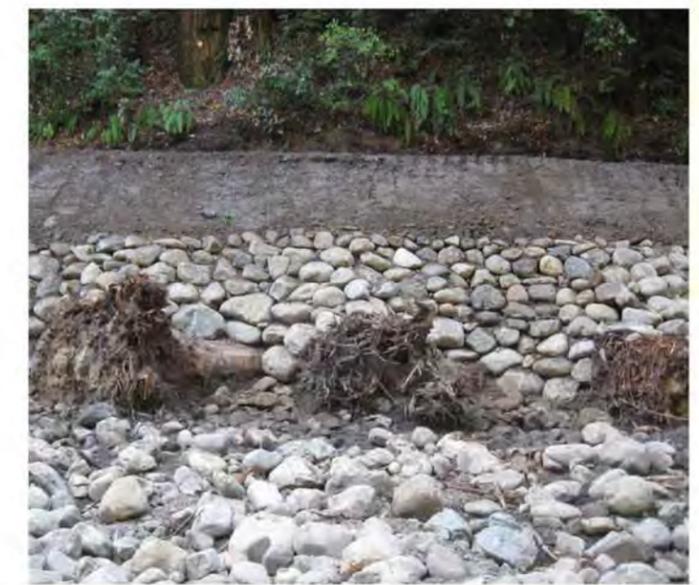
Plate 5: Typical As-Built Section (A-A')

December 2015 Survey. Within the year after installation, the Road/Bank Repair site experienced an approximately 1.7-year return interval storm event that appears to have caused up to approximately 1 ½ feet of scour upstream of the A-A' cross-section line and some localized aggradation downstream. Two incipient pools (0.32 and 0.78 feet deep) have formed within the project reach and one incipient pool (minimum depth of 0.62 feet) was logged approximately 50 feet upstream of the farthest upstream rootwad location. Although not observable in the thalweg survey, the thalweg has been pushed out toward the center of the channel and finer sandy sediments have been deposited behind the rootwads. These channel changes are represented in Figure 7.
