## ANALYSIS OF BIODETERIORATION IN TIMBERS IN 50 YEAR OLD BARN AT JACKSON STATE FOREST

John R. Shelly

Report No. 35.04.183

May 1990

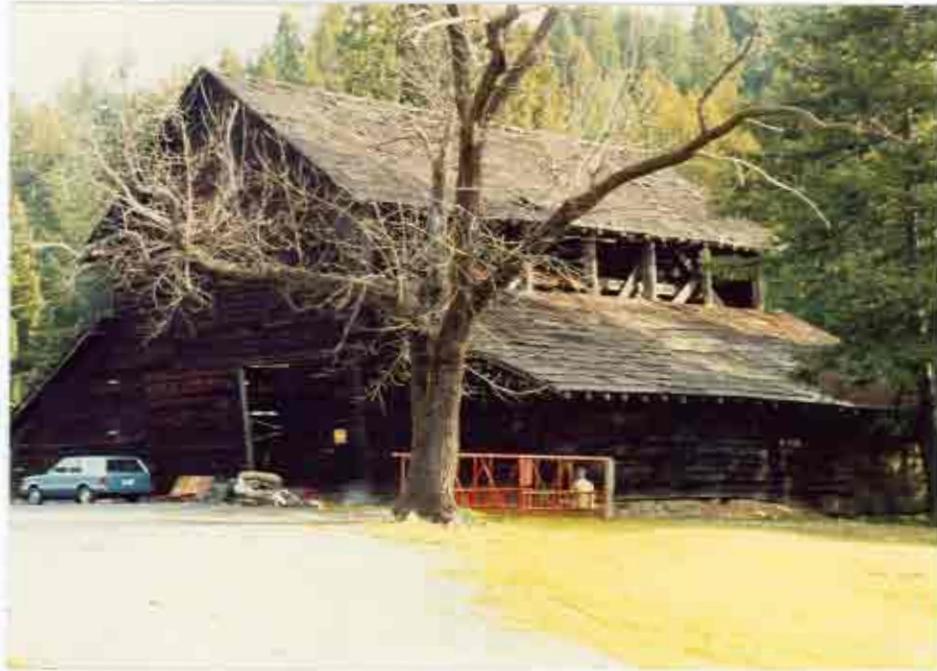
*Figure 1.* - Historic "Cat" Barn at Camp 20 in Jackson State Demonstration Forest, Mendocino County, CA

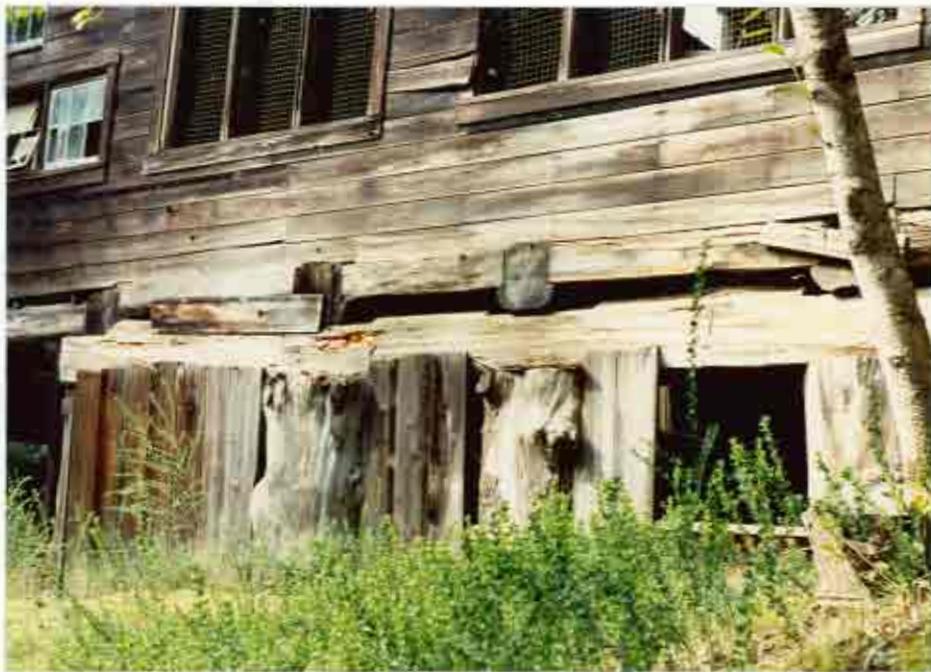
The barn is built along the bank of Chamberlain Creek, so that the floor at the front of the barn is at ground level but the rear of the barn is elevated because of the slope of the creek bank (*Figure 2*). The barn is constructed on a wood foundation of round redwood piers or columns supporting large redwood girders. The columns

*Figure 2.* - Rear of the Barn, showing the elevation of the Main Floor at the Creek Bank

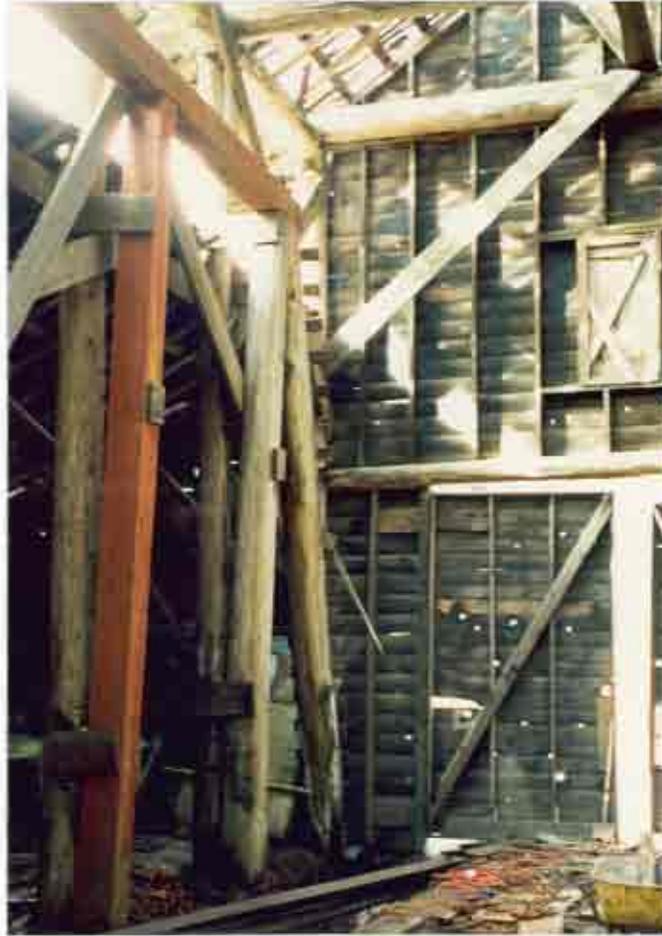
(poles) supporting the superstructure of the gantry bay, bear directly on the large floor girders running east to west (*Figure 3*). These columns support the roof beams (also round timbers) and are adjacent to the columns which support the gantry. Diagonal bracing provides lateral support to the structure (*Figure 4*). The wood framed walls are clad with redwood siding boards and the roof is covered with wood shingles.

*Figure 3. - A Girder (lower left corner) supports the vertical columns.*

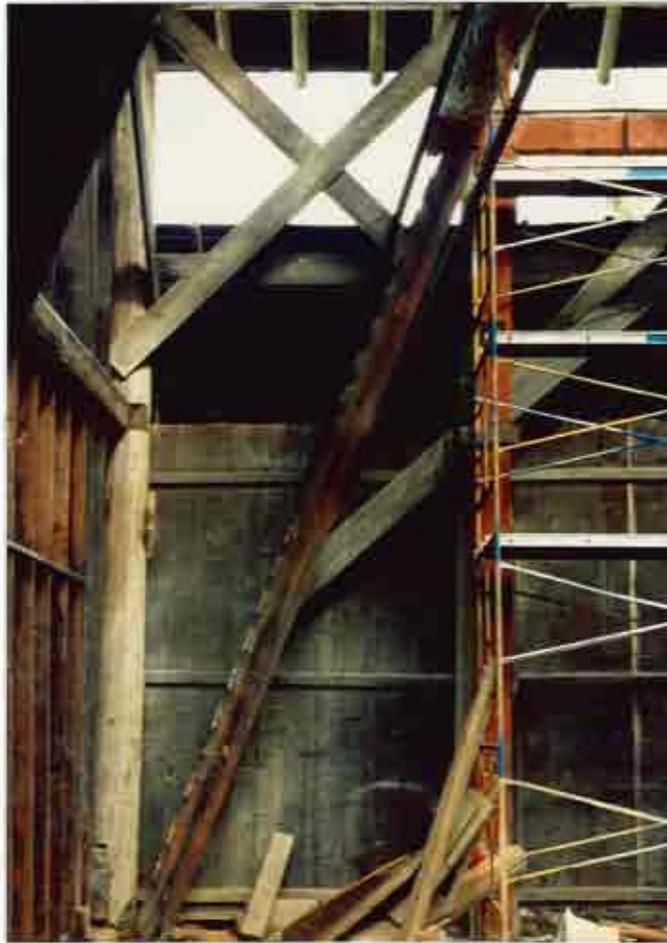
*Figure 4. - Diagonal bracing between main columns of the gantry bay.*

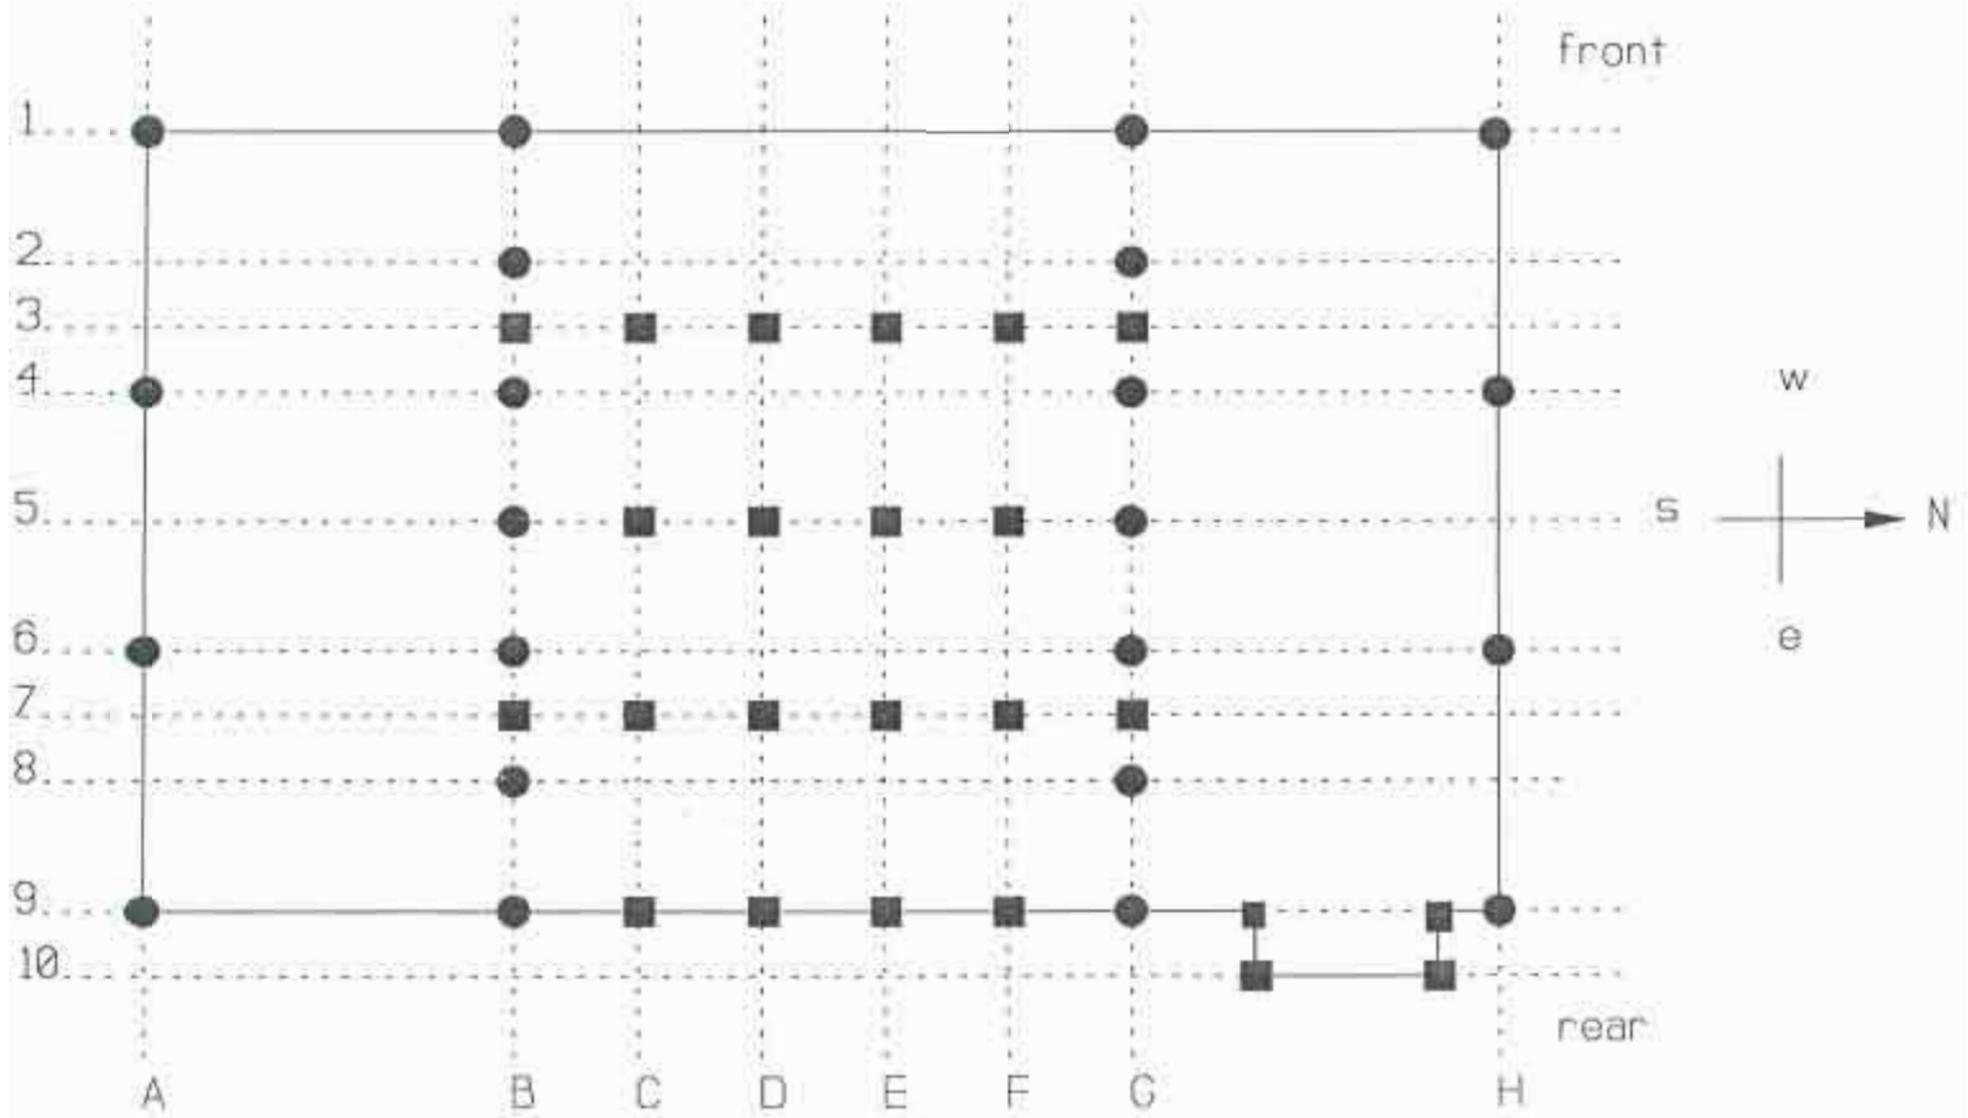
Figure 5. Sketch of Camp 20 Barn Showing the location of the main support columns (circles) and Foundation piers (squares)

The floor of the gantry bay is supported by a system of wood piers (along lines B, C, D, E, F, and G in Figure 5) and girders (*Figure 6*). This area is at a lower elevation than the two wings; it was apparently dug out to provide access beneath the floor. All of the piers are in direct contact with the ground and were found to be severely decayed at the ground line when sounded with the geologist's hammer.

The most serious deterioration was found in the substructure of the gantry bay. All of the piers are severely decayed at the ground line and in danger of failing completely. The piers along lines C, D, E, and F and along lines 3 and 7, in Figure 5, support the floor only and not the superstructure. The piers supporting girders B1-B9, B9-G9 and G1-G9, however, are the main foundation for the barn superstructure. If these piers fail the barn will collapse. While these piers presently support the limited loads they are subjected to, they will continue to deteriorate as long as they are in ground contact. Future failure is certain.

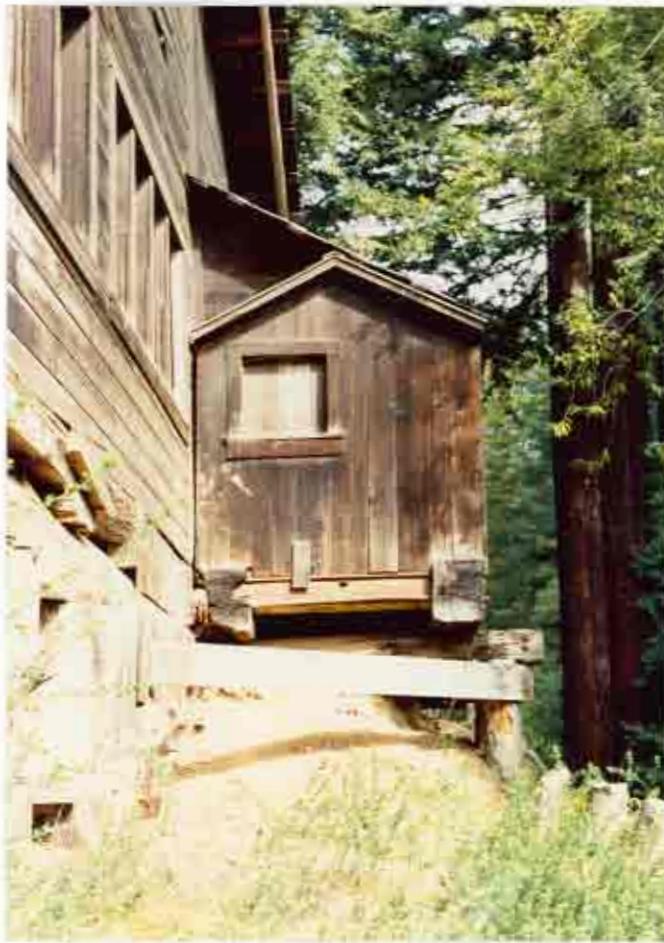
The shed attached to the rear of the barn was apparently built on two beams (Figure 20) which are supported by girder G.3/9-G.3/10 and column G.3/10 and by beam G.7/9-G.7/10 and column G.7/10 (decimal notation indicates position between grid

*Figure 20.* - Shed attached to the rear of north wing of the barn supported by a pier and girder frame.

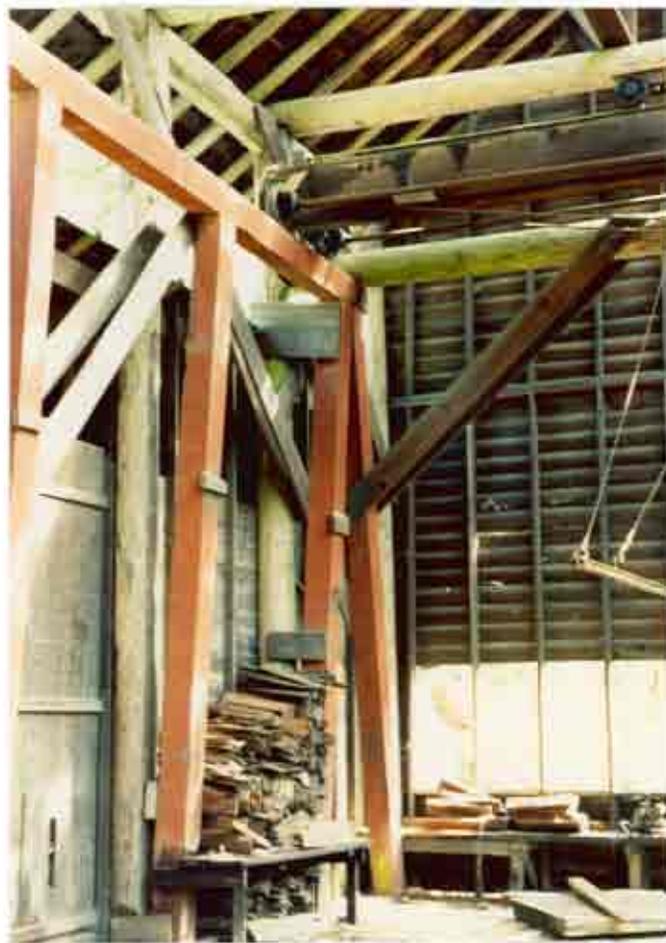
The main columns of the gantry bay provide the support for the superstructure of this bay and also the inside walls and roof beams of the north and south wings (*Figure 26*). The columns along the north side (line G of Figure 1) of the gantry bay are in remarkably good condition. No evidence of decay was found in these columns. The columns along the south side of the gantry bay have varying degrees of decay.

*Figure 26.* - Interior view of the northeast corner of gantry bay.

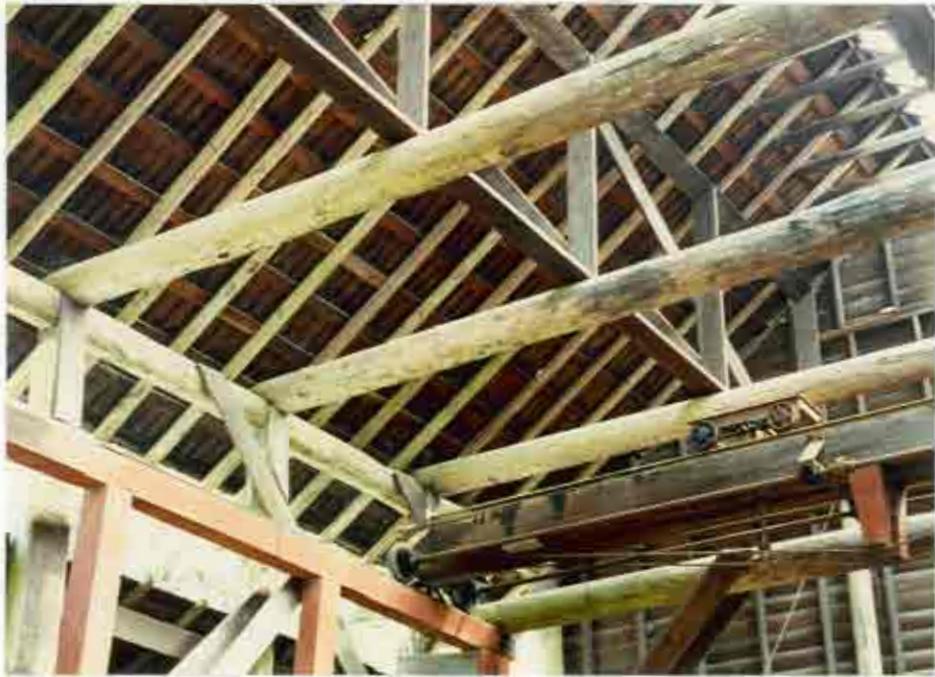
The roof assembly is supported by a system of notched round timbers forming girders and roof beams (*Figure 29*). The seven main support columns on each side of the gantry bay support a girder running east to west along line B and G. Into these two girders are notched seven roof beams (also round timbers). Trussed framing, bearing on the roof beams, supports roof joists (small diameter poles). The roof is clad with wood shingles on spaced sheathing.

*Figure 29.* - Interior view of the northeast corner of the superstructure in the gantry bay.

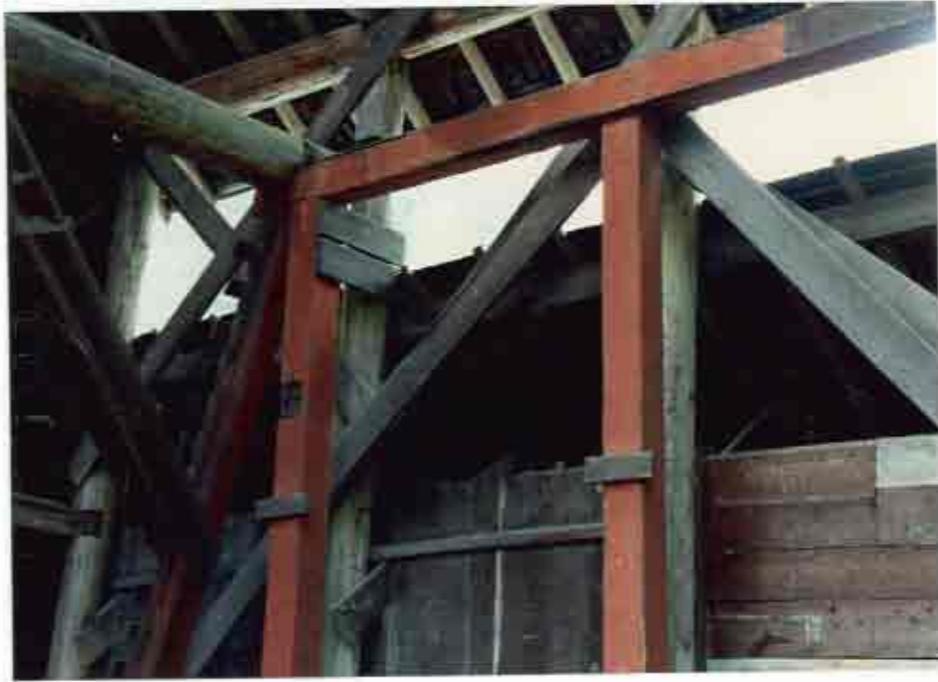
The overhead crane is supported by a frame of large redwood timbers. This gantry frame consists of 5 vertical columns along each side, each side supporting a girder (*Figure 36*). Each side of the gantry frame is connected together by end beams. The gantry beam at the west end failed and was removed at an earlier date (*Figure 37*). The crane was mounted onto a movable carriage that could traverse the gantry along rails on the top girders (*Figure 29*).

*Figure 36.* - Northwest corner of the crane gantry.
