# GEOTECHNICAL INVESTIGATION

ARTESA VINEYARDS  
RESERVOIR AND SUMP POND  
ANNAPOLIS ROAD  
ANNAPOLIS, CALIFORNIA

11673.1

June 25, 2002

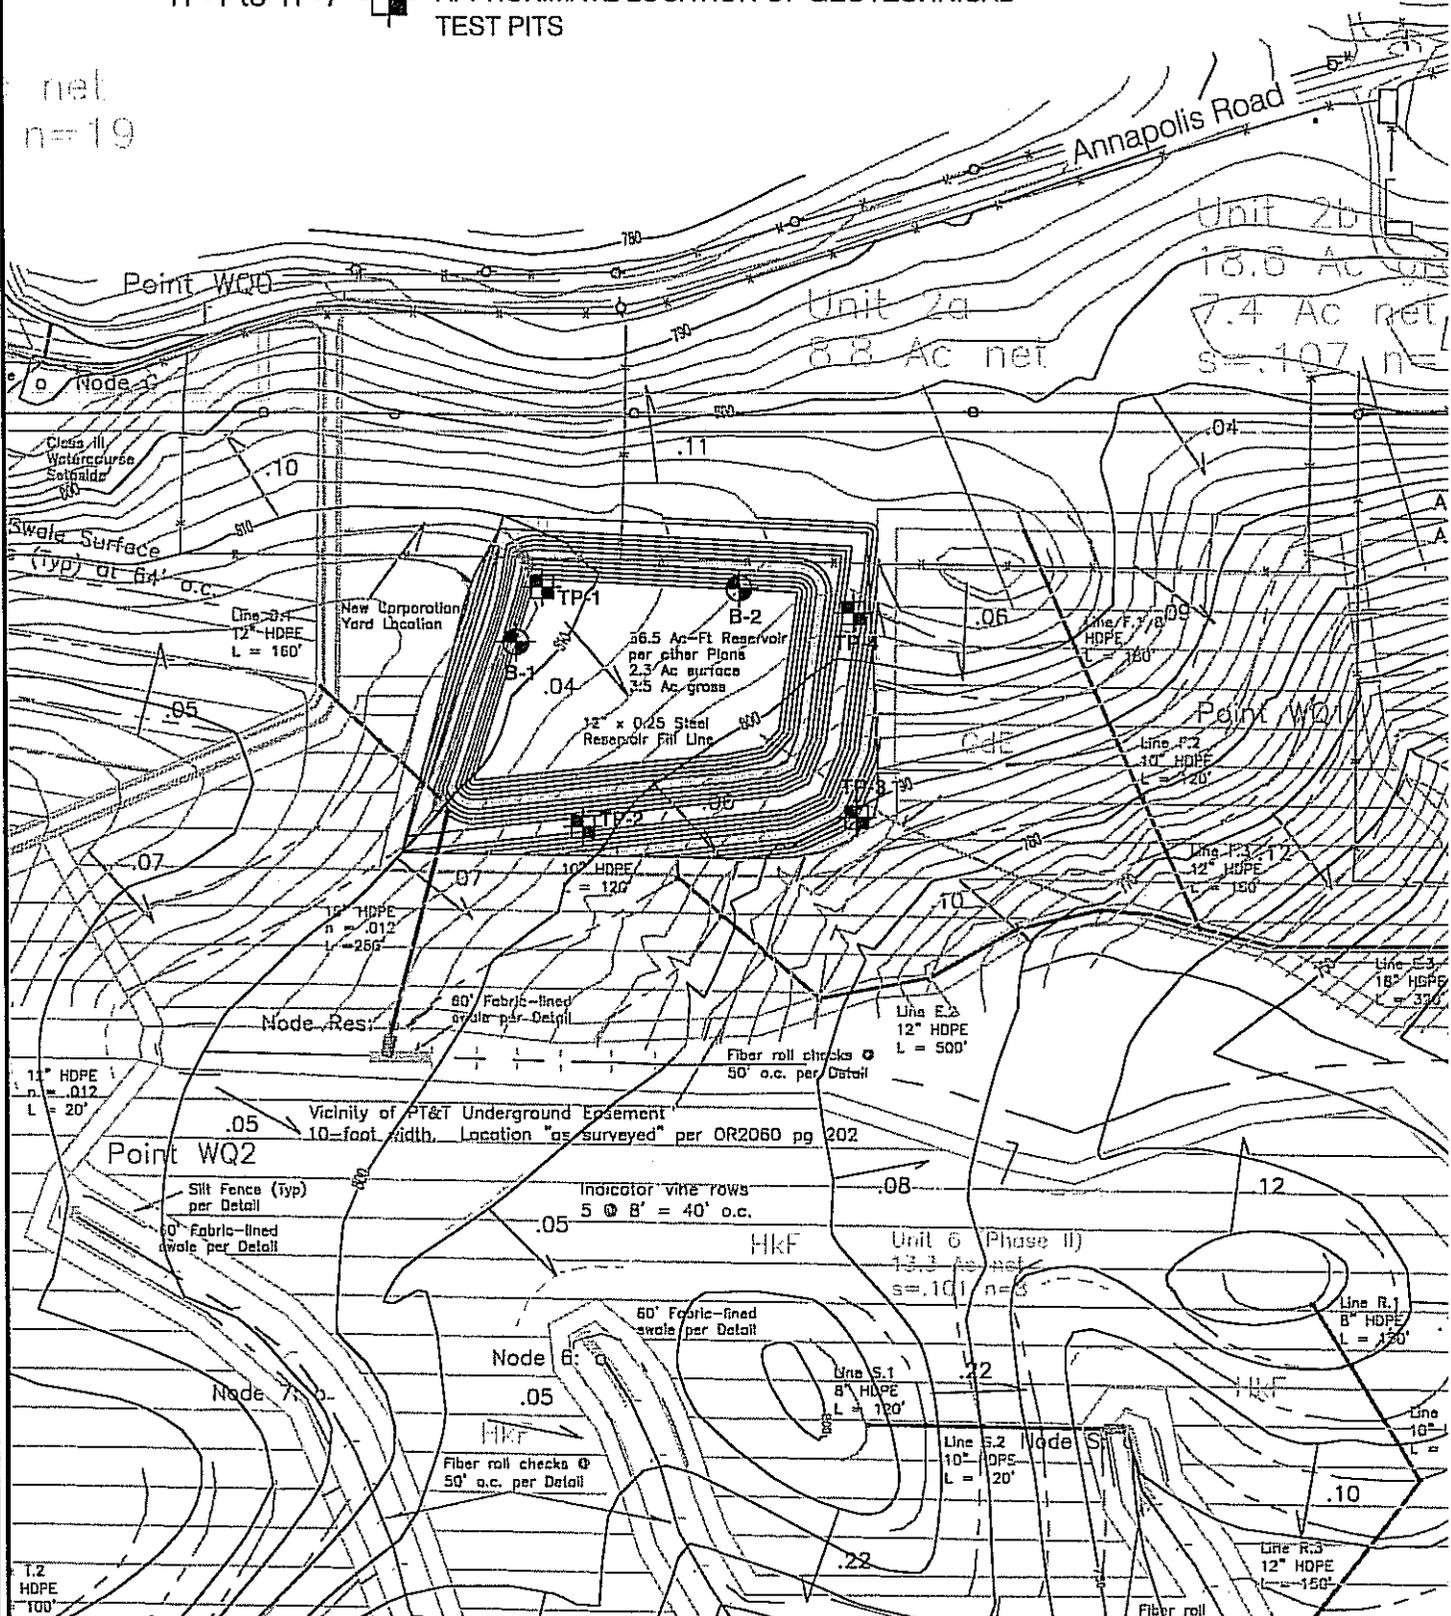
APPROXIMATE LOCATION OF GEOTECHNICAL TEST PITS

## REFERENCE:

Site Plan, dated March 30, 2002,  
prepared by Erickson Engineering Inc.

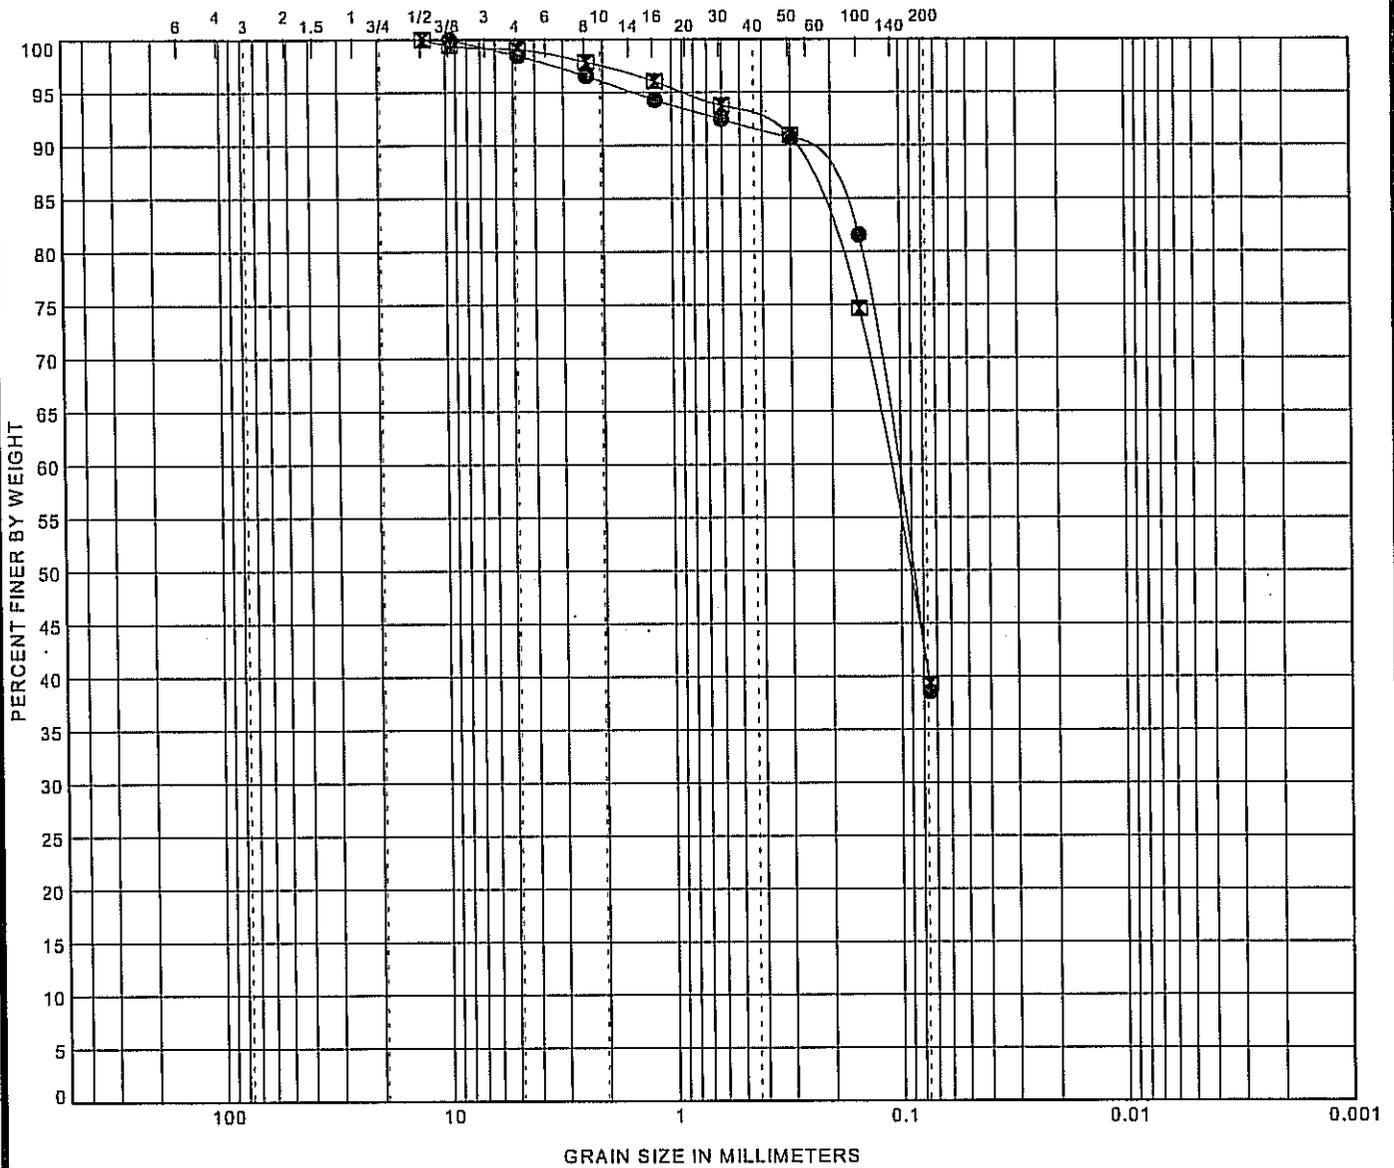
U.S. SIEVE NUMBERS

HYDROMETER

COBBLES	GRAVEL		SAND			SILT OR CLAY
	coarse	fine	coarse	medium	fine

Specimen Identification	Classification	LL	PL	PI	Cc	Cu
● TP-1 11.0 ft	ORANGE TO OLIVE SILTY SANDSTONE					
☒ TP-2 6.0 ft	ORANGE TO OLIVE SILTY SANDSTONE

Selected samples were tested in our laboratory to determine their pertinent geotechnical engineering characteristics. Laboratory testing consisted of moisture content/dry density, maximum dry density (compaction), triaxial compressive strength, classification (particle size analysis), and remolded permeability (triaxial cell). The laboratory test data are summarized on the logs, alongside the samples tested, in the manner shown on the Key to Test Data on Plate 9. Compaction test data are presented on Plate 12, the sieve analysis are plotted on Plate 13, and the permeability test results are summarized on Plate 14.

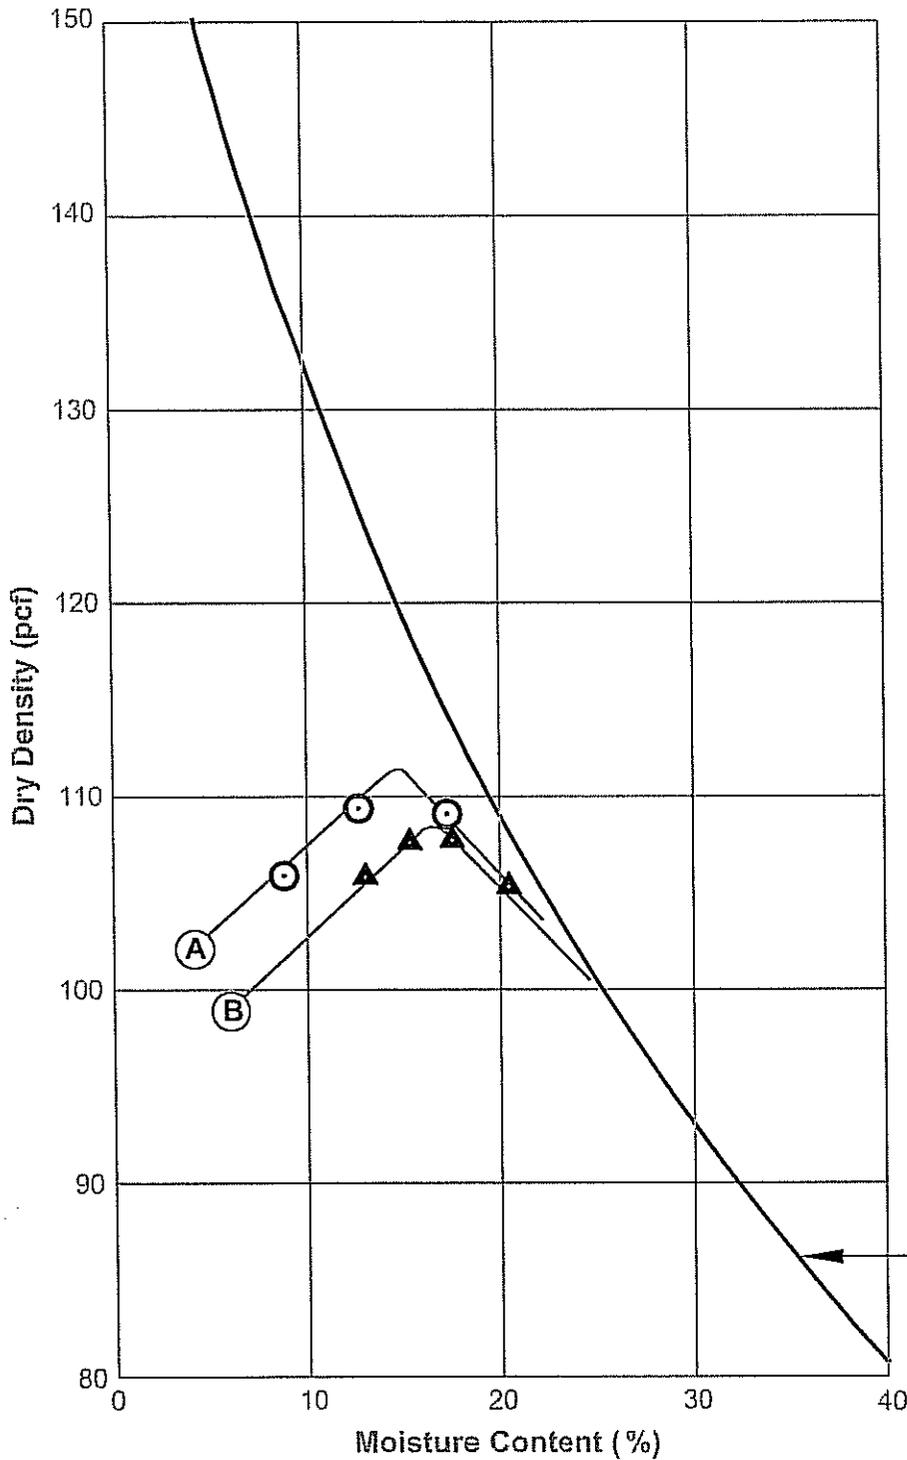
TEST METHOD  
ASTM D1557-91

○ Laboratory  
Compaction  
Point  
▲ Point

Reference Line – 100% Saturation  
for 2.70 Specific Gravity

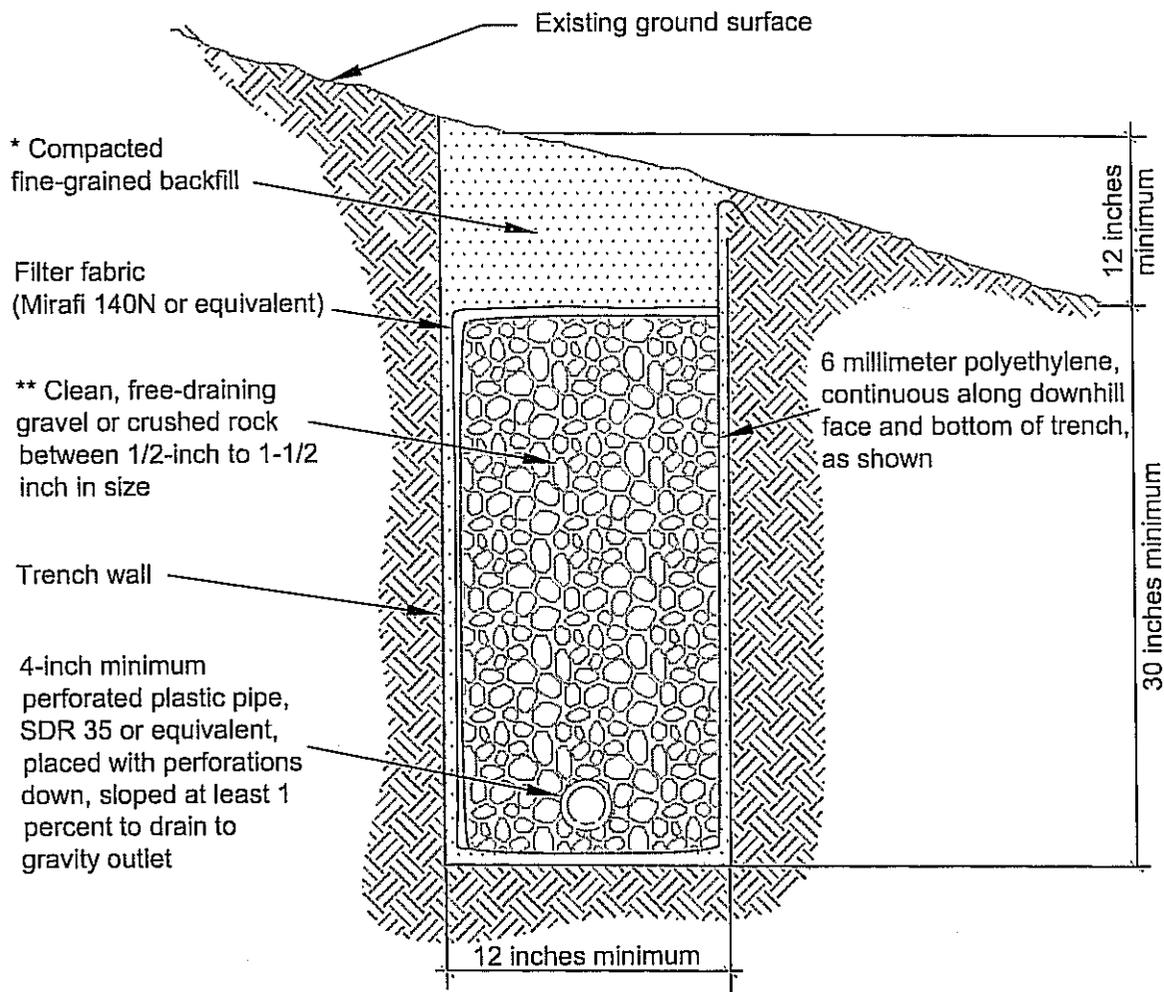
**15**

\* 90 percent relative compaction minimum in accordance with ASTM D 1557-78 Test Method

\*\* Or, as an alternative, use Class 1 Type A Permeable Material per Caltrans specifications
